COMMERCIAL INSPECTION REPORT

12/5/2020

Richardson, TX

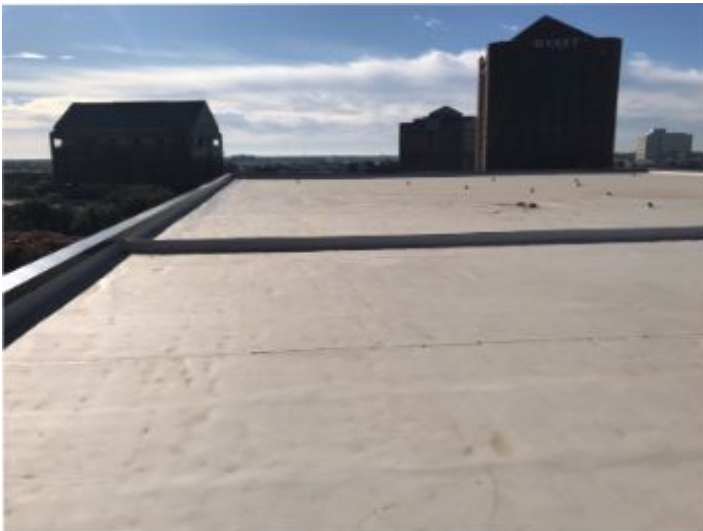
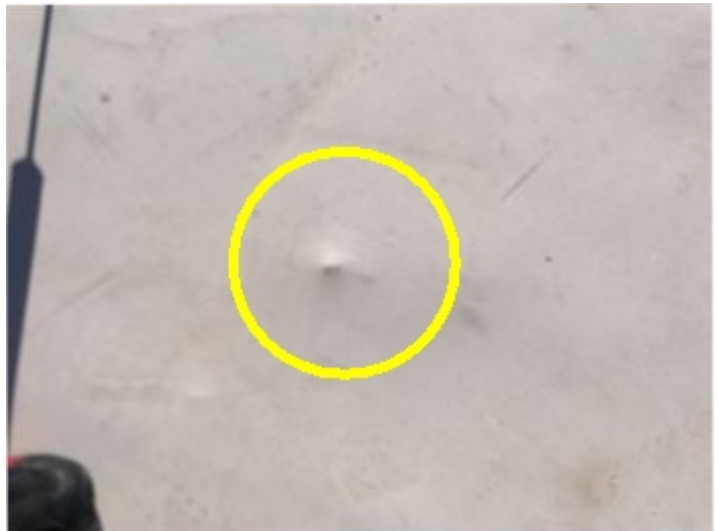
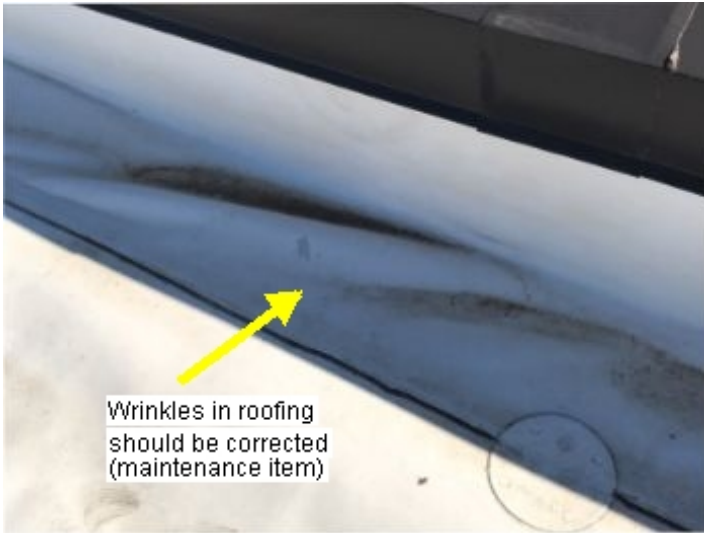
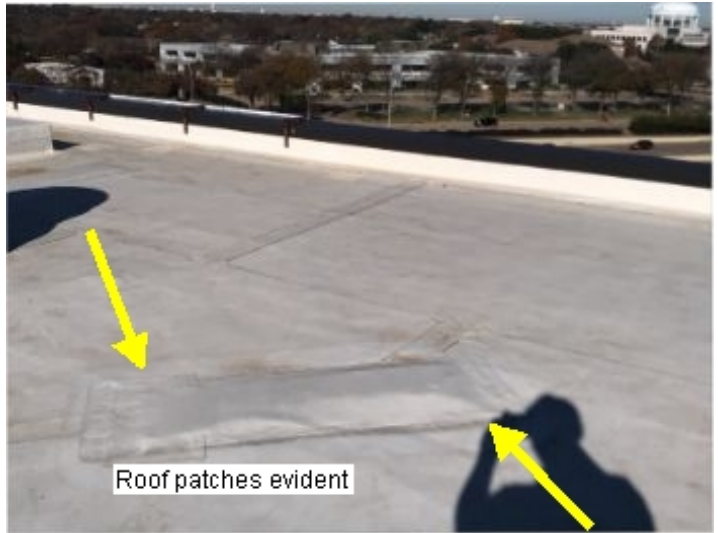
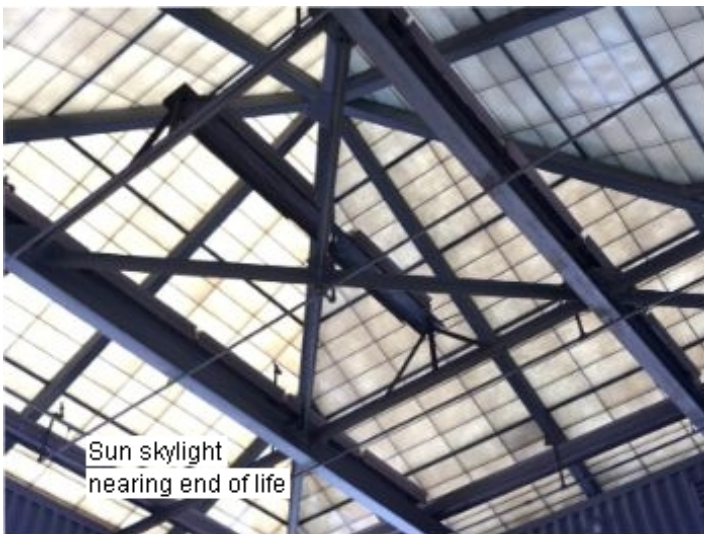
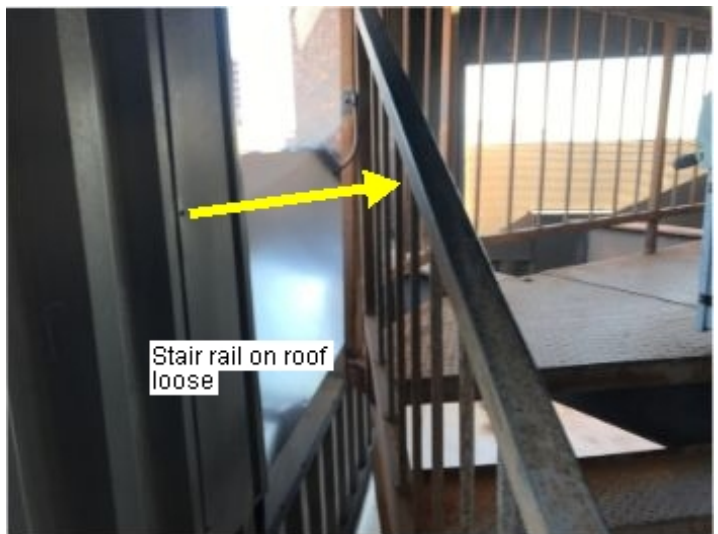
Roof Materials		
Page 12 Item: 1	Roof Materials Comments	<ul style="list-style-type: none"> • Evidence of ponding was observed in one or more areas. Low spots in the roof allow water to collect and will eventually cause roof leaks (if not already leaking). Further evaluation by a qualified roofing contractor is recommended. • Roofing material appeared to be improperly installed in one or more areas. This may contribute to roof leaks and further evaluation by a qualified roofing contractor is recommended. See photos. The roof was rated 8.5 out of 10; with some maintenance recommended. <p>Items such as improper corners, improper sign fasteners, some roof drains need weep holes added. Did recommend that interior upper foyer area be covered with TPO to extend life as it is rusting and deteriorated now.</p> <p>See photos</p> <p>Rofer that conducted the evaluation is Red Bird Roofing. 972-596-5328</p>

Roofer that conducted the evaluation is Red Bird Roofing. 972-596-5328

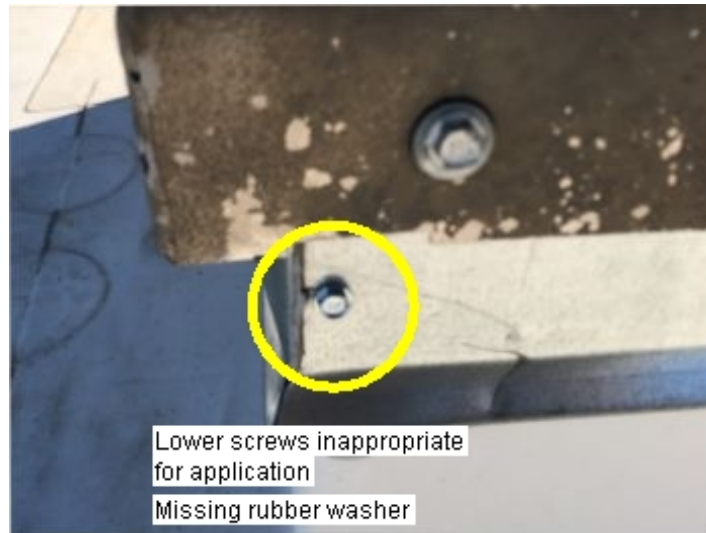
- Some the screws and bolts for the roof accessories were improperly installed.

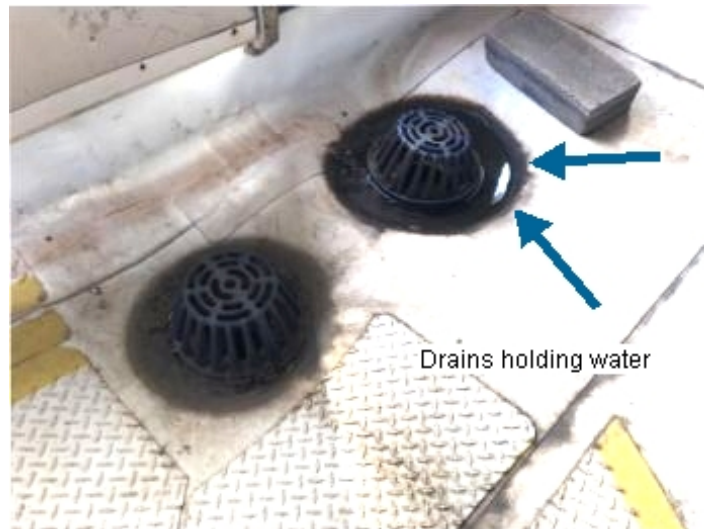
- Ceiling drains were present throughout but in most instances one of each pair of drains was not equipped with the proper weep holes and the result was ponding around the drain.

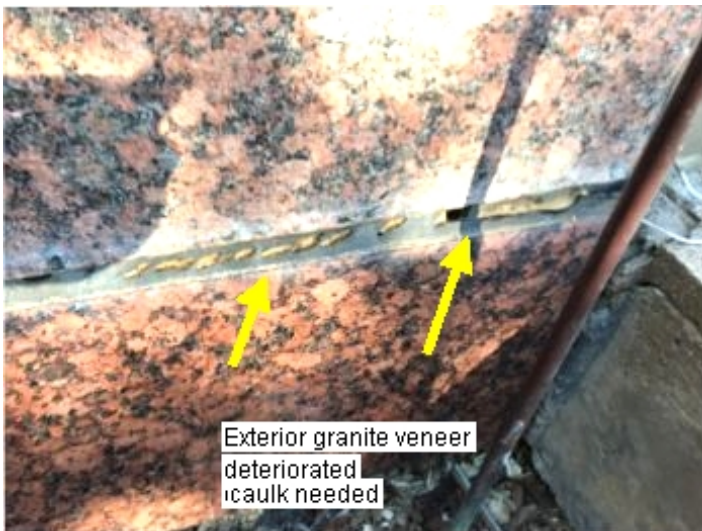
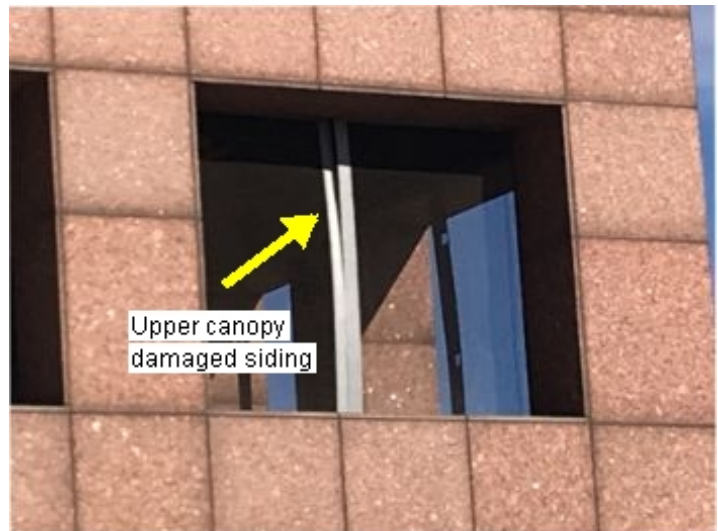
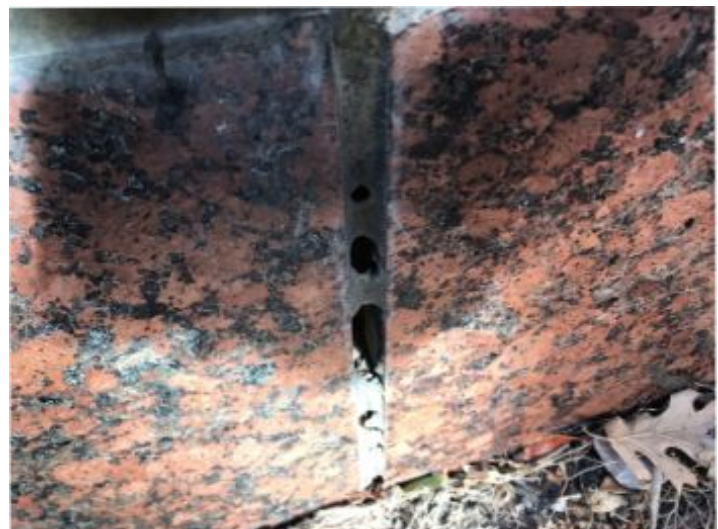
3. Stone Damage

- Sidewall cladding consists of stone.
- Loose and/or damaged stone/granite materials were noted on one or more areas of the building. This may allow water damage to the underlying surfaces. Correction by a qualified contractor is recommended.
- Typical caulking maintenance is recommended at one or more areas in order to prevent moisture damage to the underlying wall surfaces.

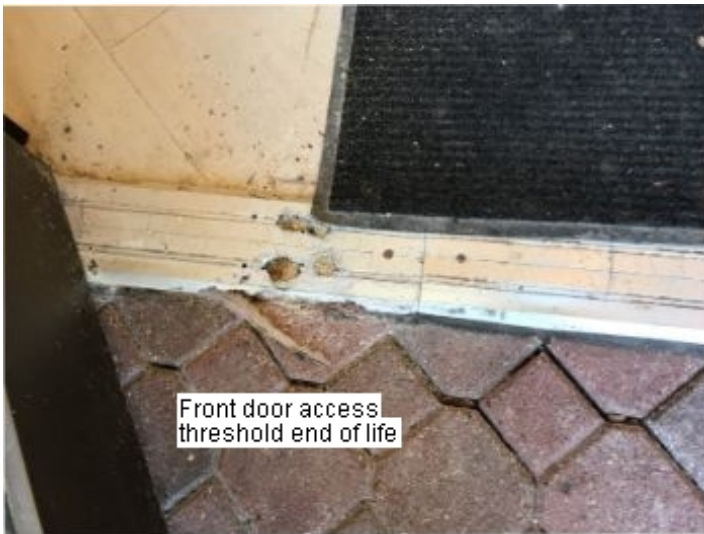
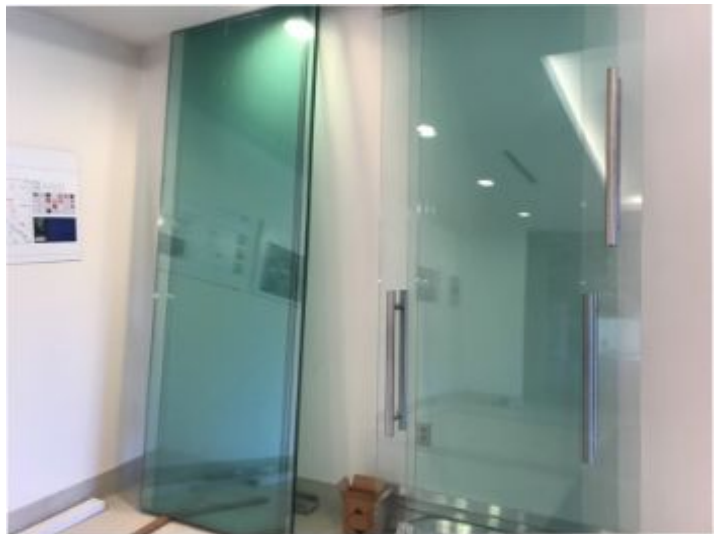
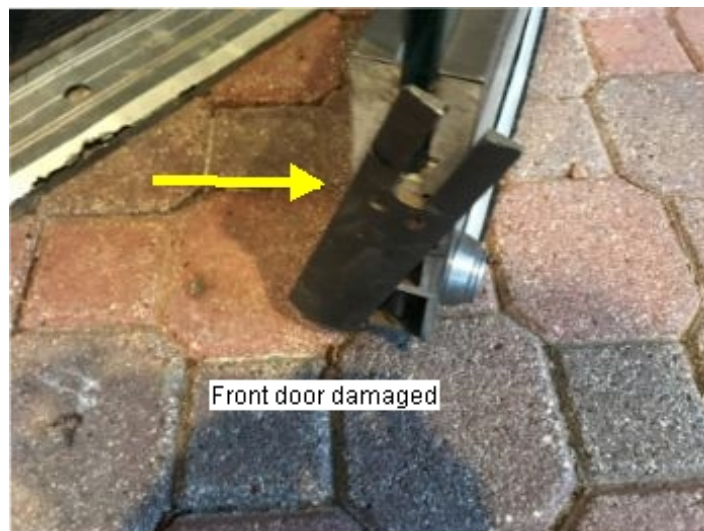
- The south exterior walk doors are metal glad. The front doors are glass.
- The doors at the following locations are in need of minor repairs or adjustments: Front doors; threshold and kick plate edge

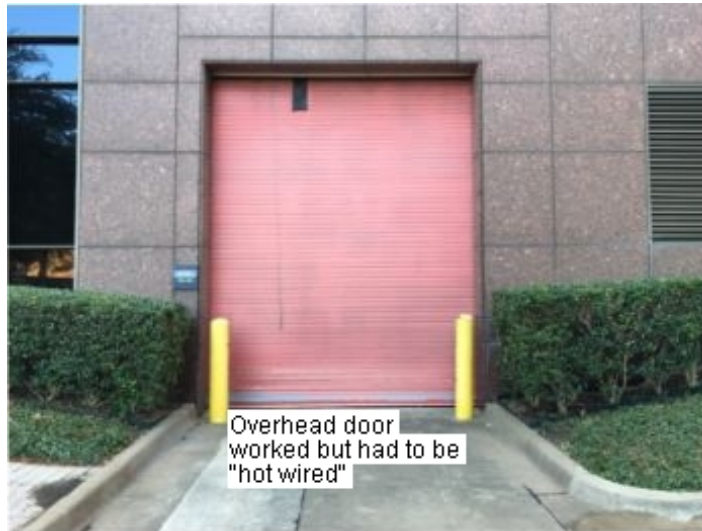
- A representative sampling of the door operation was conducted, and all appear to be in adequate condition
- Automatic door operators are NOT functioning correctly. The control box is no longer attached and requires a key to operate. None of the keys provided would operate the overhead door controls. Creative persistence on behalf of the inspector allowed for testing and the door did open and close. Recommend replacement of the door control.

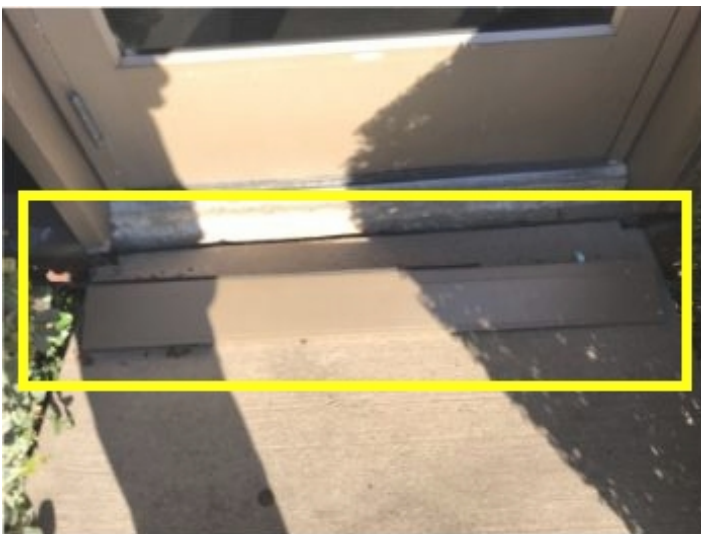
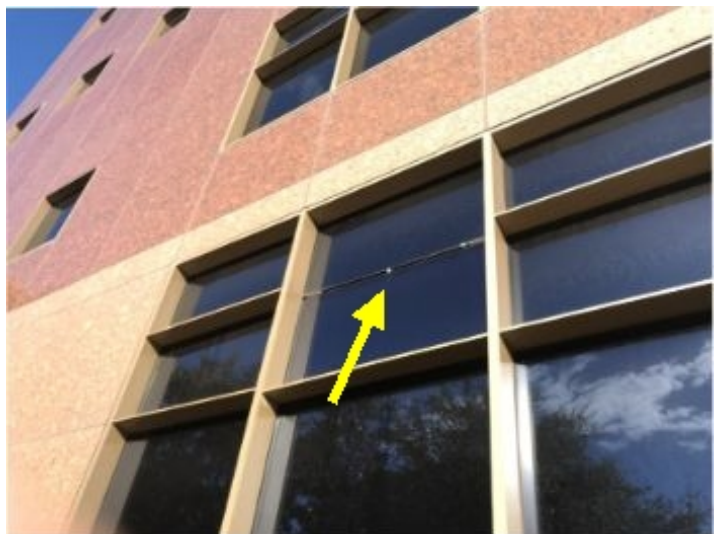
- The exterior window "ribs" are falling (see photos) and there exterior window frames are damaged or in need of paint.

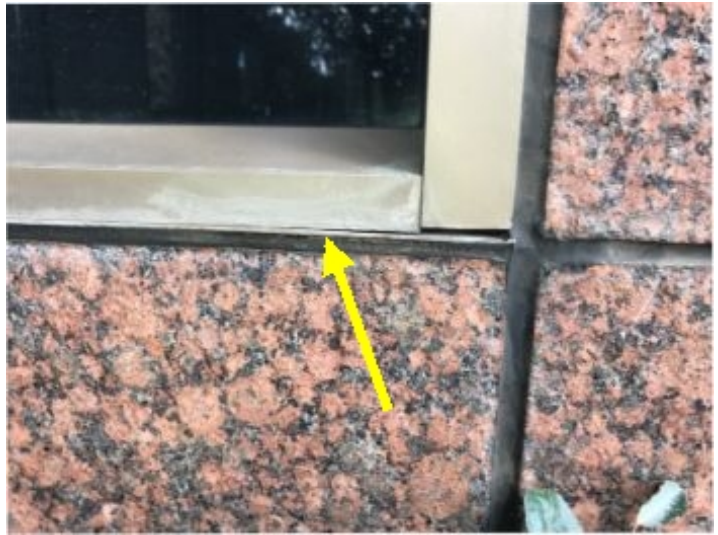
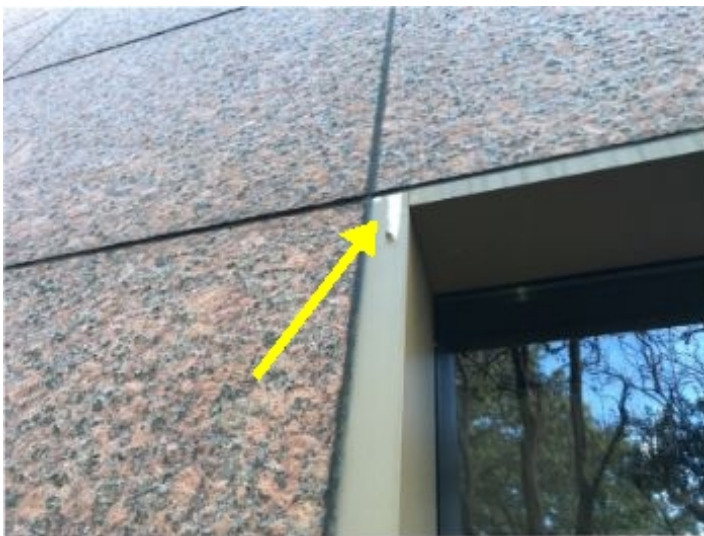
Page 22 Item: 4	Fenestration System - Windows	<ul style="list-style-type: none"> • The exterior window "ribs" are falling (see photos) and there exterior window frames are damaged or in need of paint.
Weatherproofing

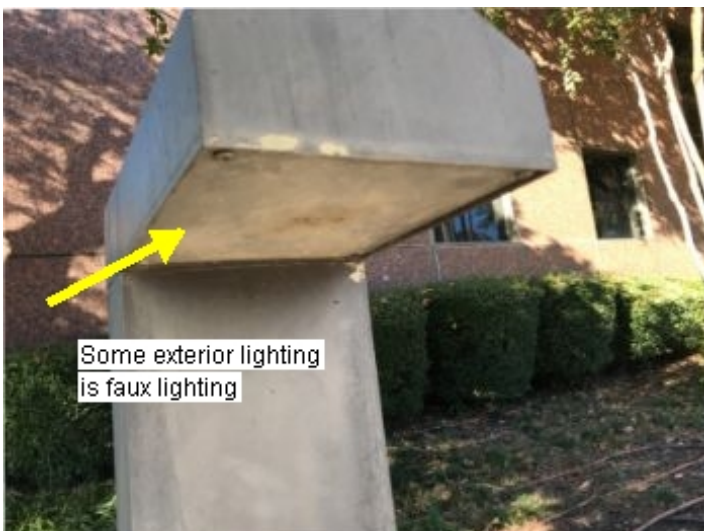
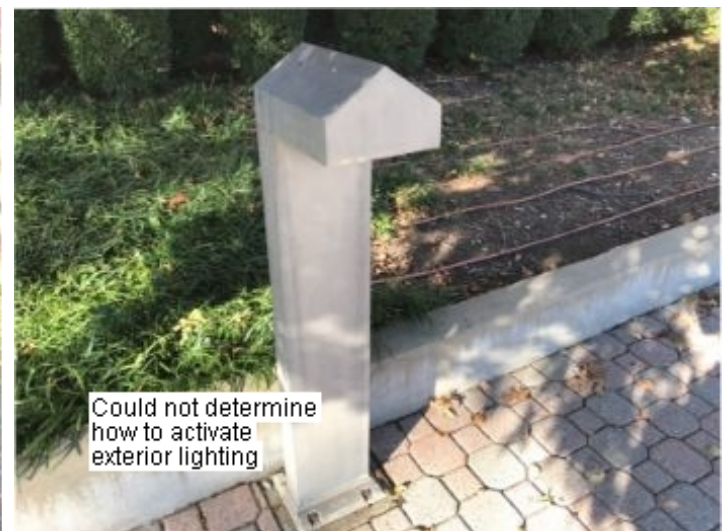
- Building lighting is present and appears functional and satisfactory.
- The parking lighting could not be tested.
- The exterior walkway lighting could not be activated.
- The parking lighting may be inadequate for the size of the parking area (3 poles; with one heavily covered/blocked by trees).
- Some exterior walk way lights were noted to be faux lights.

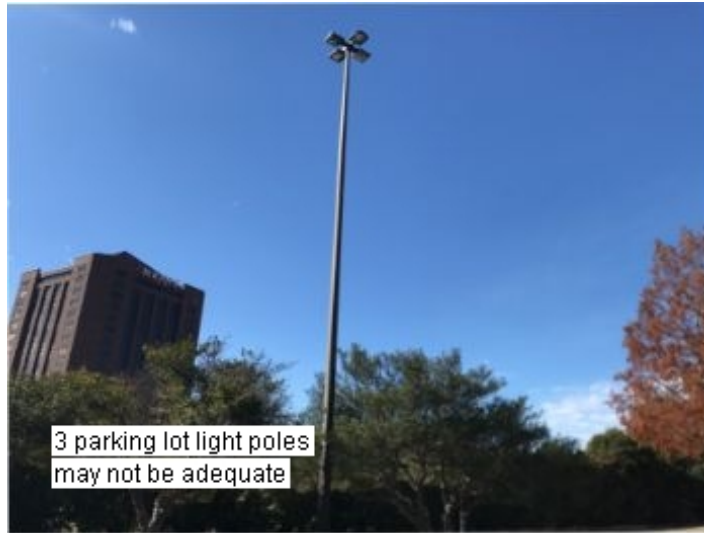
3 parking lot light poles
may not be adequate

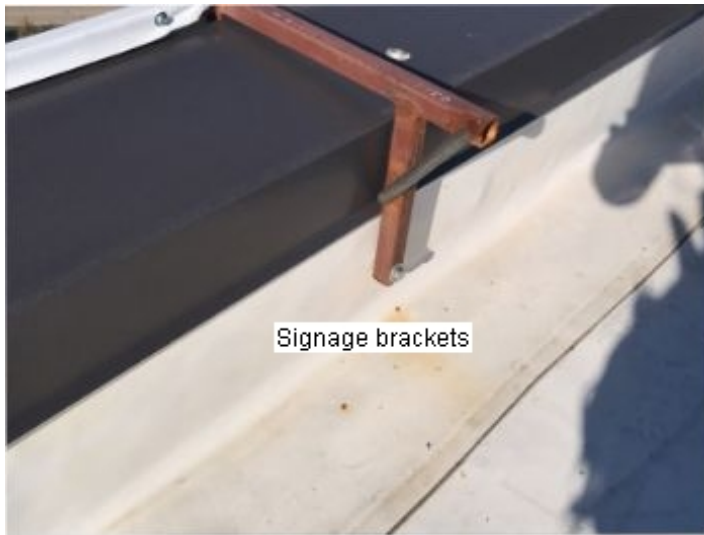
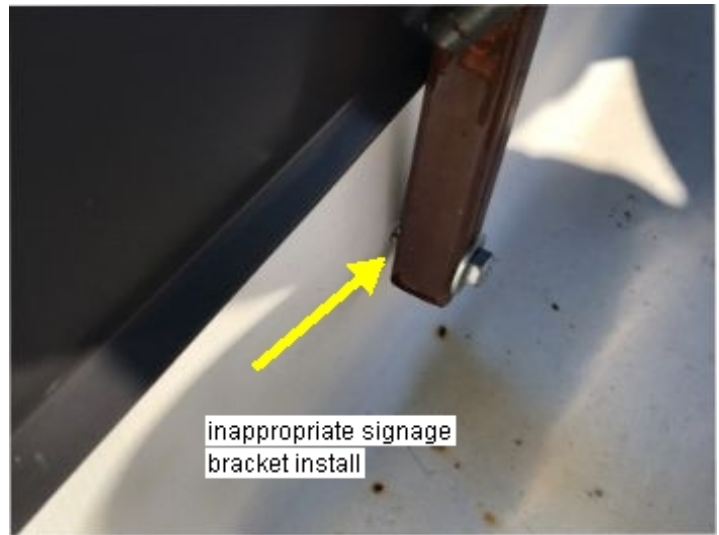
- Exterior signage was added by the current Realtor/broker. It was installed in such a way as to compromise the TPO roof covering. Recommend review by roofer and/or signage company. Red Bird Roofing (972) 596-5328

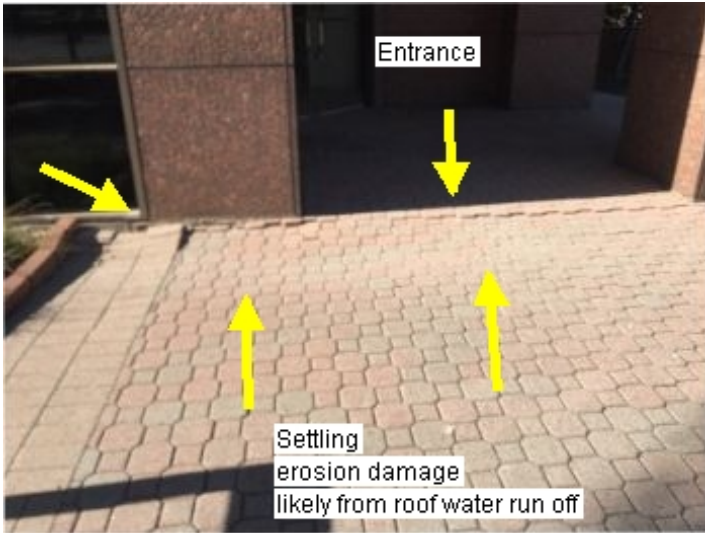
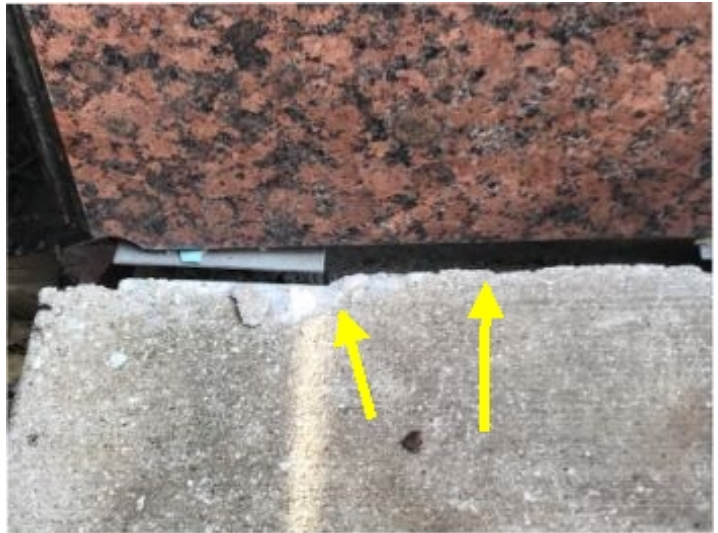
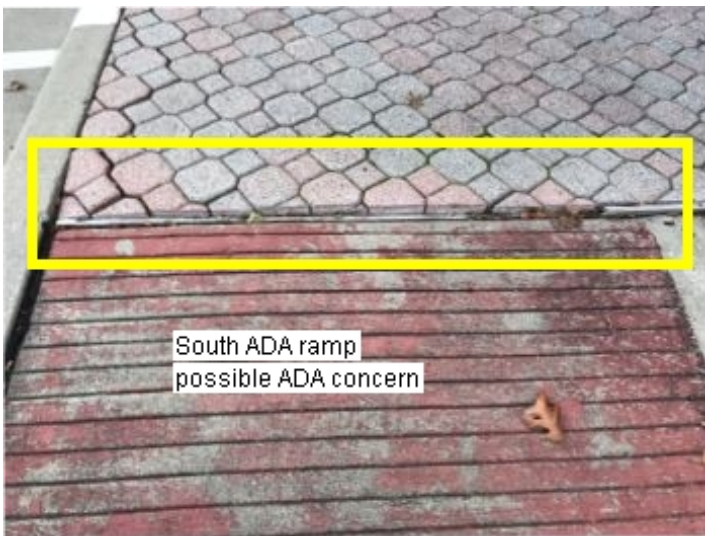
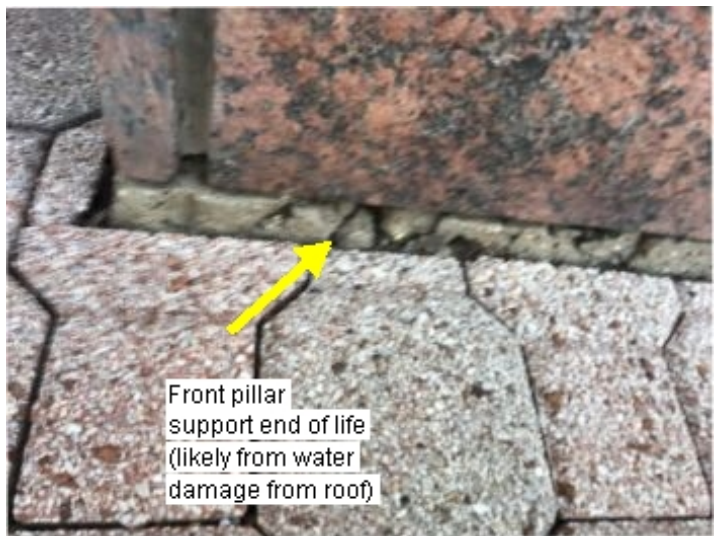
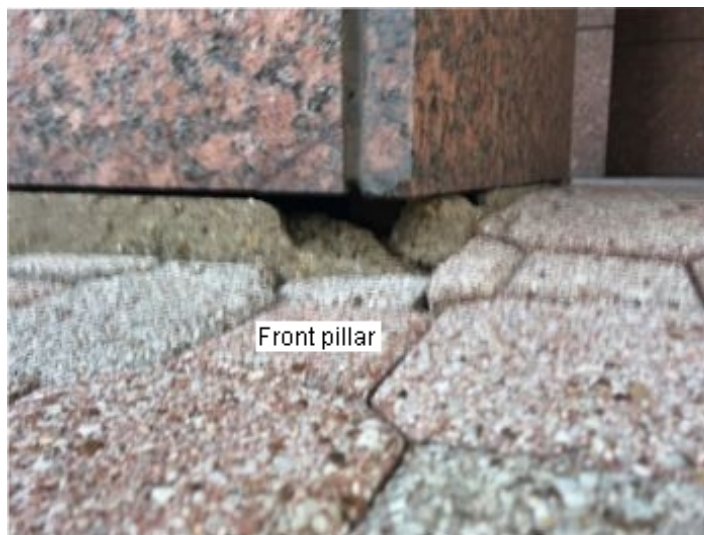
- Surface is raised or settled at the following areas: South ramp of handicap parking area (raised); front entrance area/foyer (settling) see photos.
- A possible cause of the front foyer area settling is due to rain run off from the top-level sun roof as there is no drainage system for the water to run off the roof and instead runs down that side of the building onto the flat work.

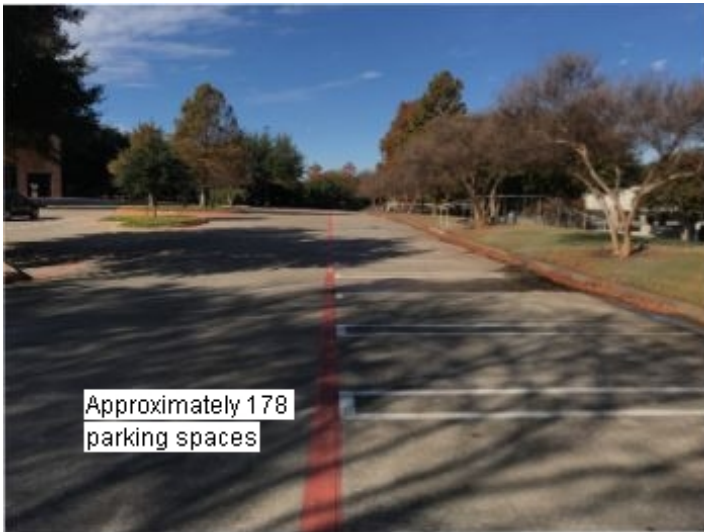
- All parking surfaces on the lot are paved with concrete.
 - Curbs and bumpers are of concrete, and all appear to be in satisfactory condition.
 - The parking is in good shape but there are a few potential trip areas. See photos. Recommend repair.
 - The curbs were found to be in satisfactory condition with few exceptions. See photos.
 - There are approximately 178 parking spaces for this property with 8 marked as handicap only.
- NOTE: there were no handicapped spaces properly marked or identified as being for a handicap van.

Approximately 178 parking spaces

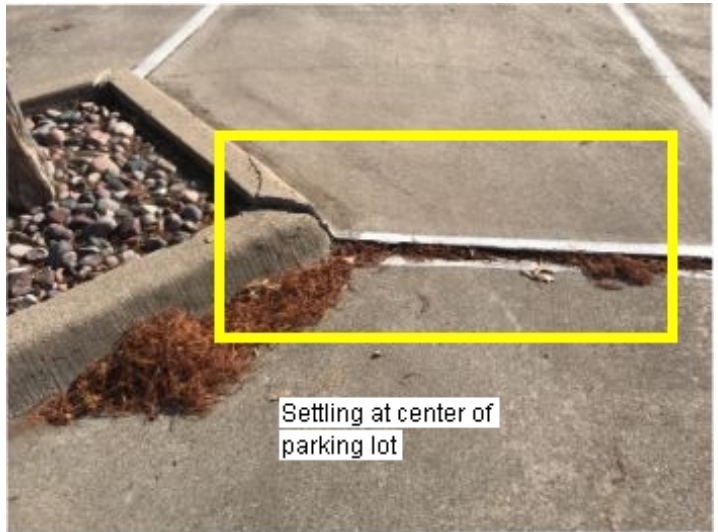
Settling at center of parking lot

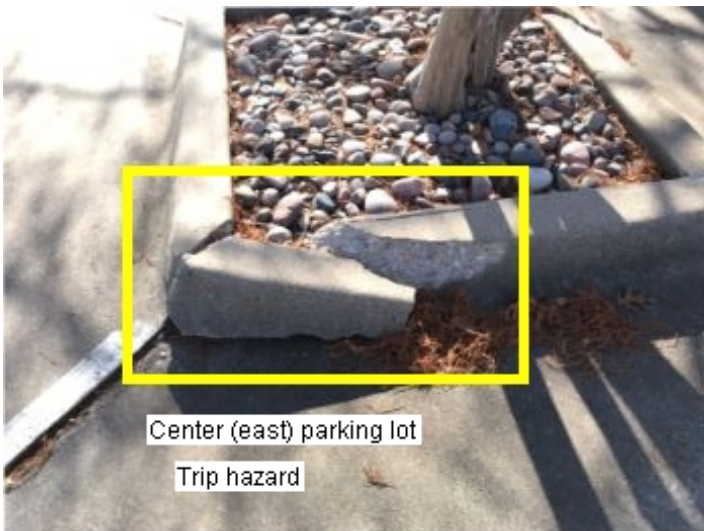
Center (east) parking lot
Trip hazard

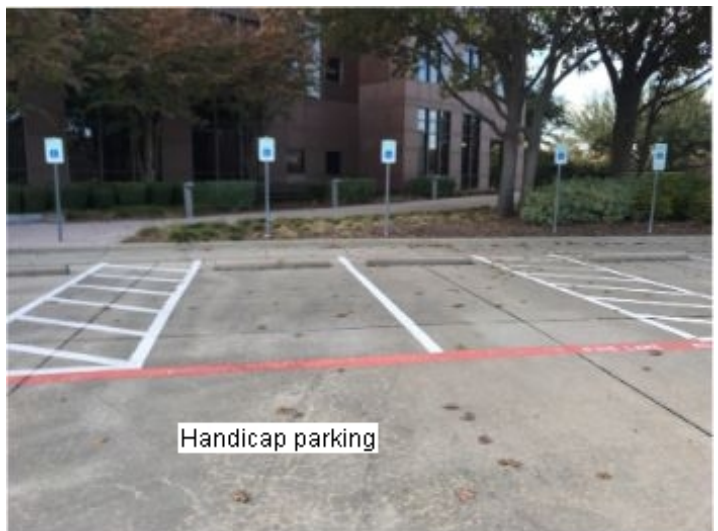
Handicap parking

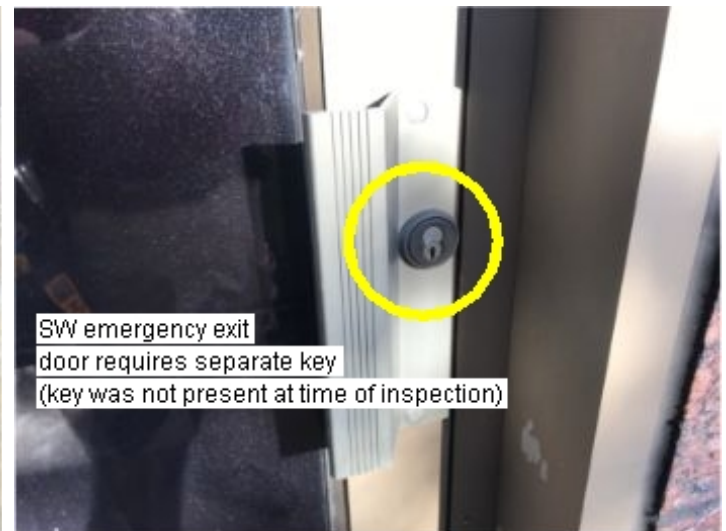
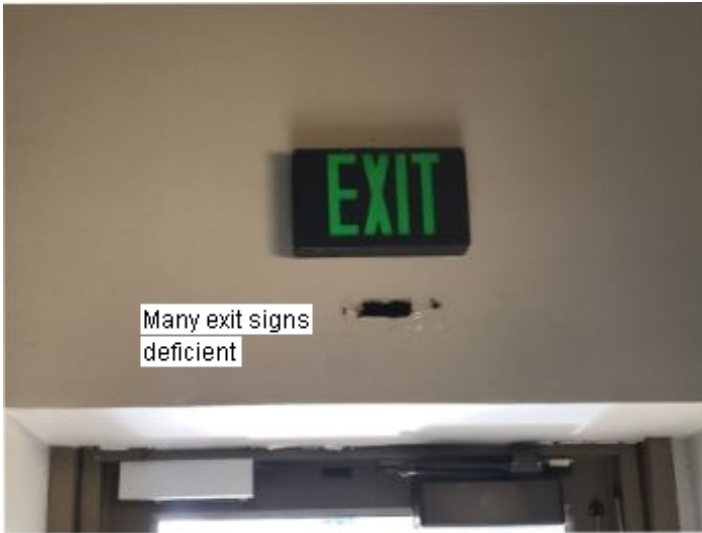
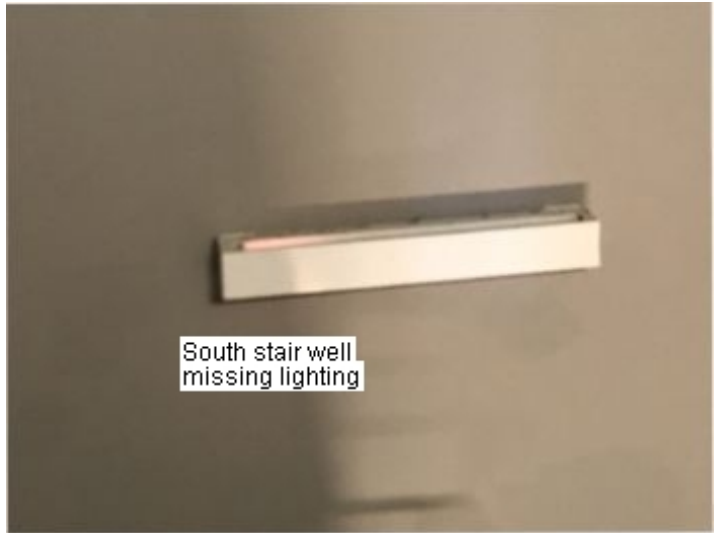
- Access and egress to the subject property are via South on Lakeside Blvd.
- There were several concerns with interior egress such as doors requiring special keys, lighting not functioning properly, exit signage not in place or functioning properly.

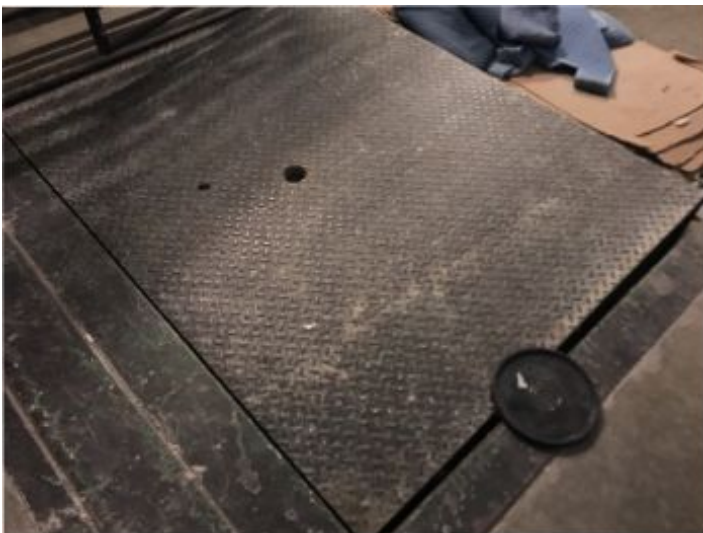
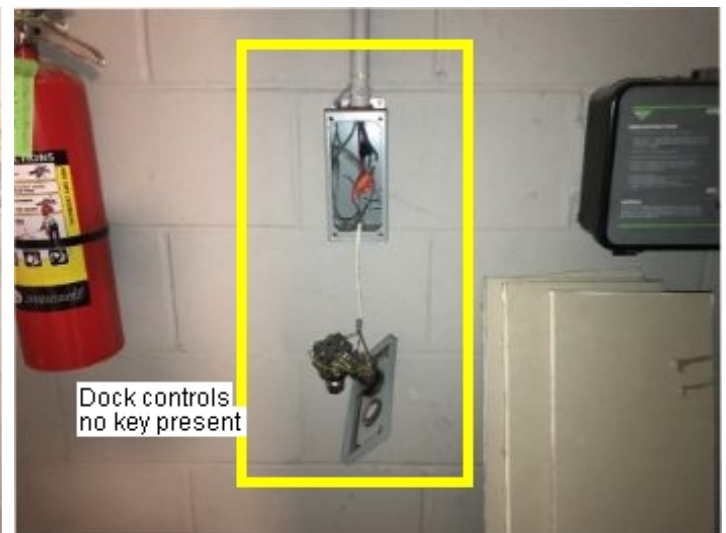
- Loading ramp(s) or dock(s) are present.
- The operation of the levelers was partially tested; but could not be fully tested due to debris in blocking full access. If desired, a specific lock leveling inspection should be performed.
- The drain at the bottom of the loading ramp or dock should be clear of debris and draining at all times. Any clogging can result in standing water or damage.
- The loading dock and ramp area is without a protective guard railing or mean to protect pedestrians from falling into the area.

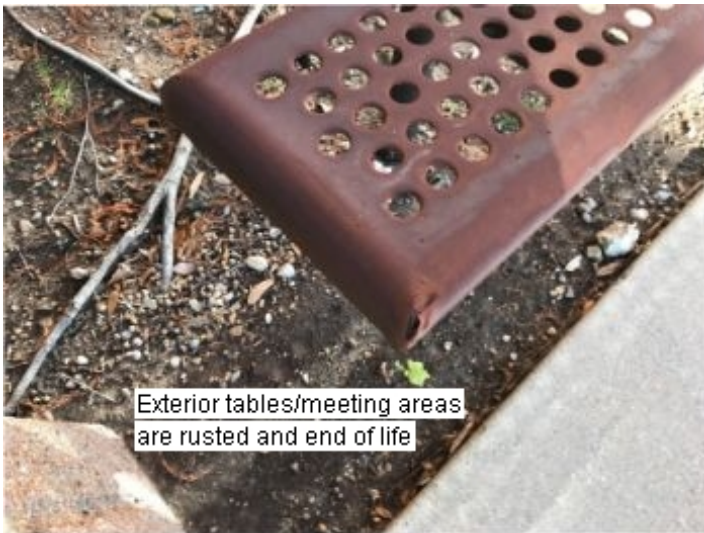
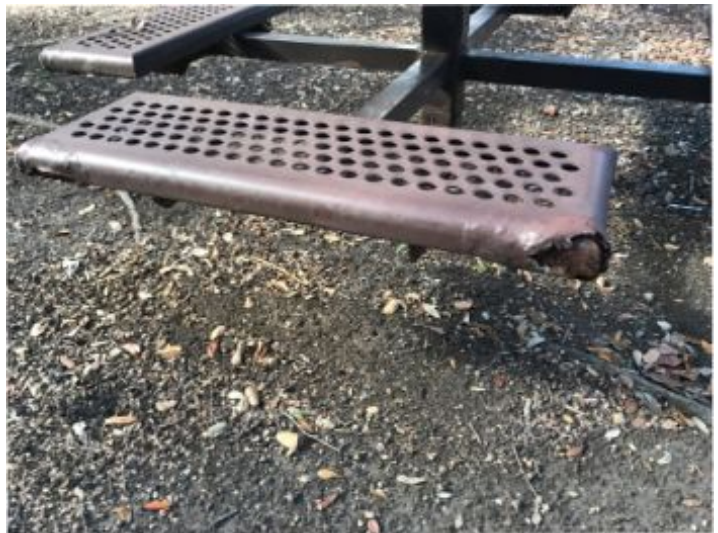
- It was noted exterior seating and picnic areas are end of life.

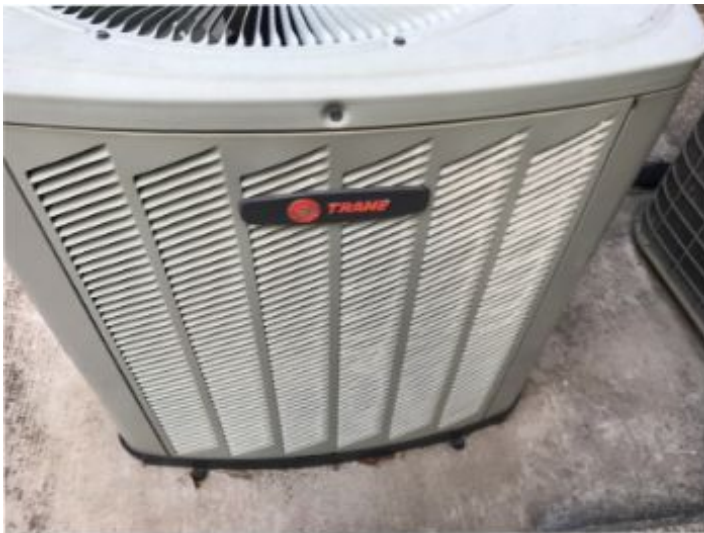
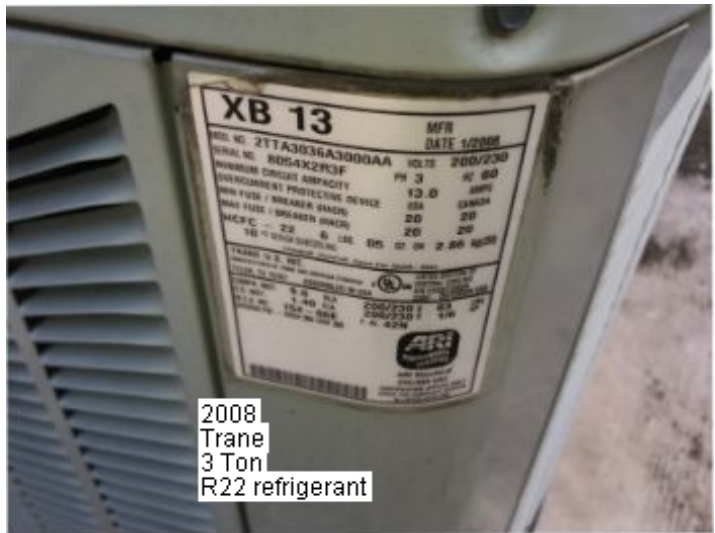
- Units were not able to be tested.
- The interior units are Payne and Trane and both are end of life with rusted coils, etc. See photos.
- The interior closet unit (Payne) seems to indicate a previous leak.
- There are blowers located throughout the building in the main work areas. The second floor blower unit was tested for Mold.
- Space heaters in the loading dock were not able to be tested.

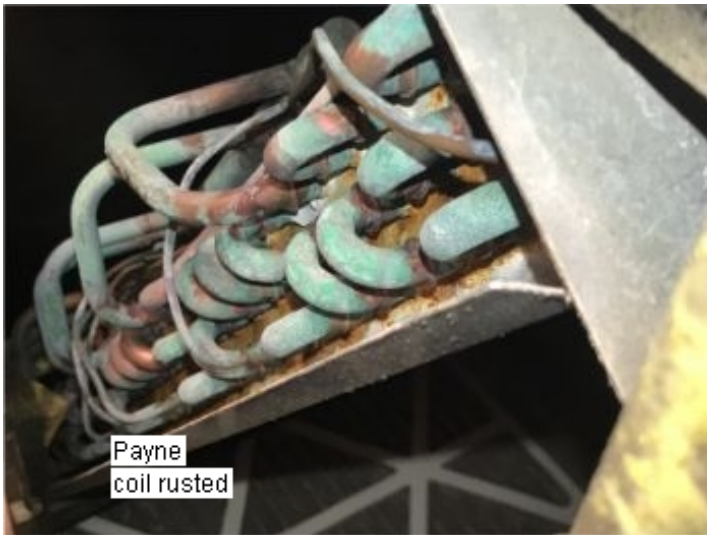
Payne
coil rusted

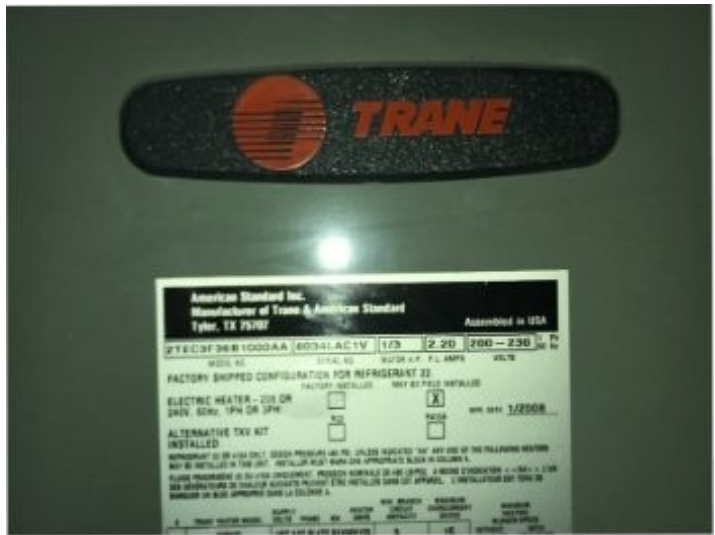
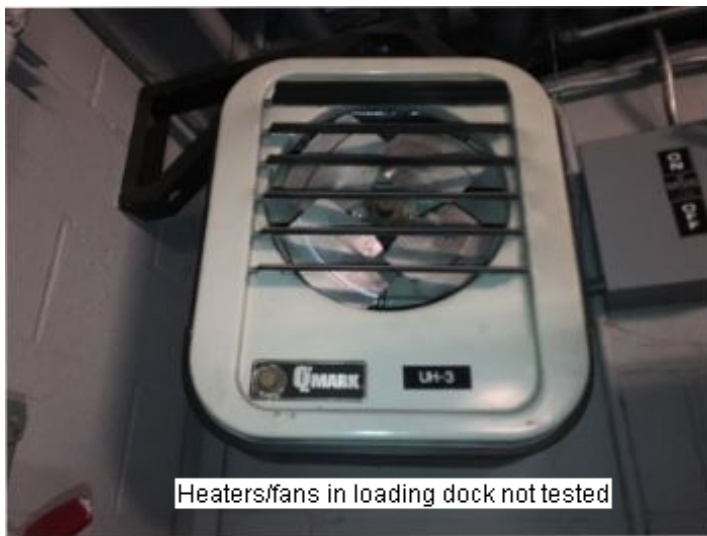
Heaters/fans in loading dock not tested

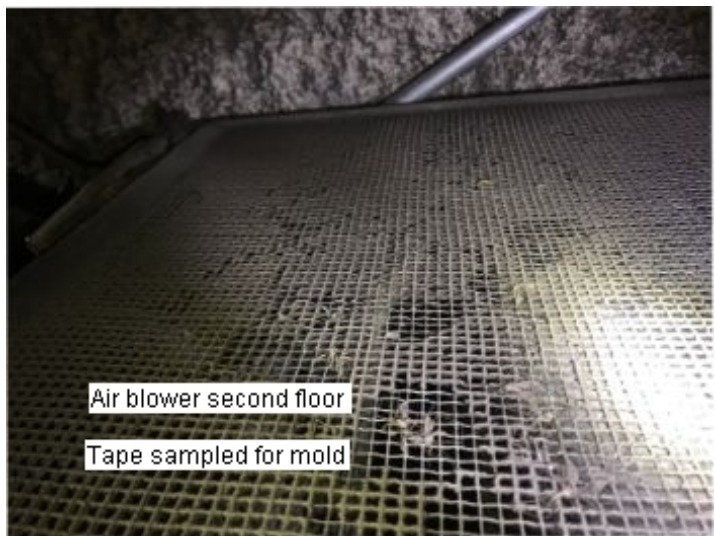
Air blower second floor
Tape sampled for mold

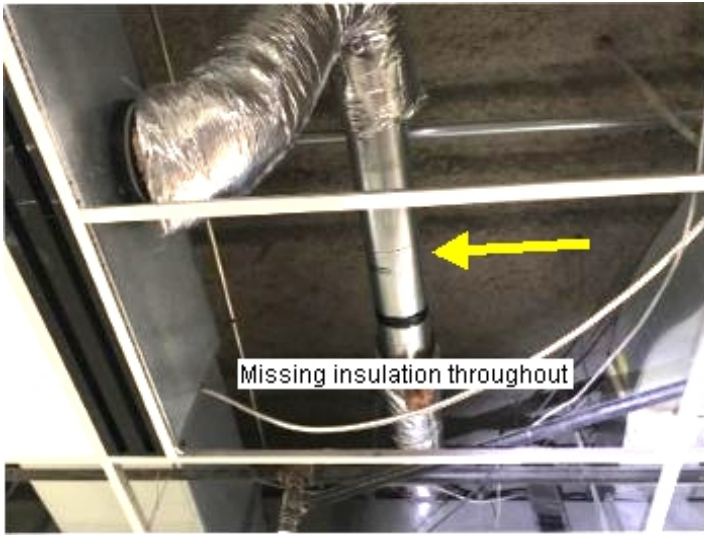
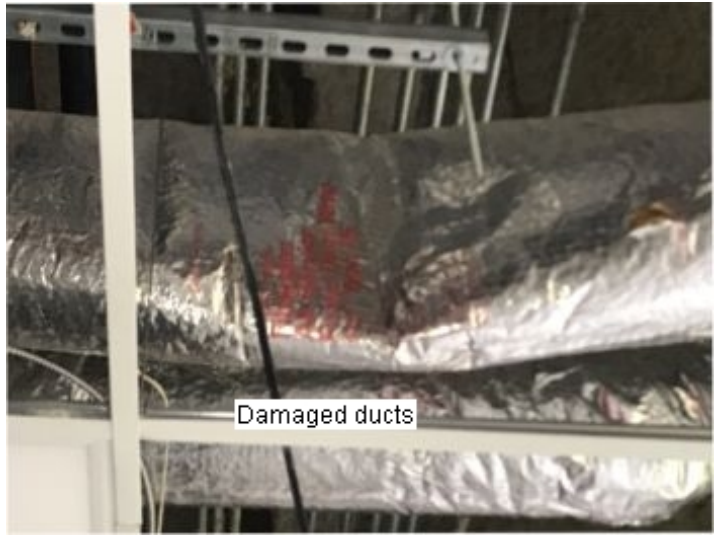
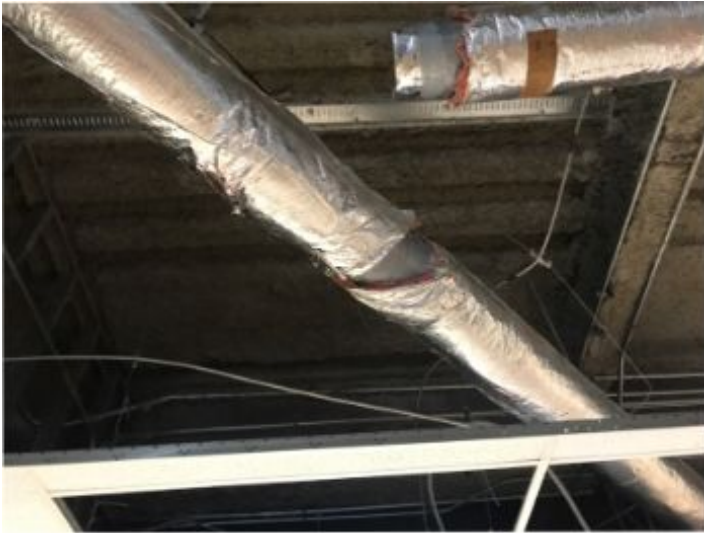
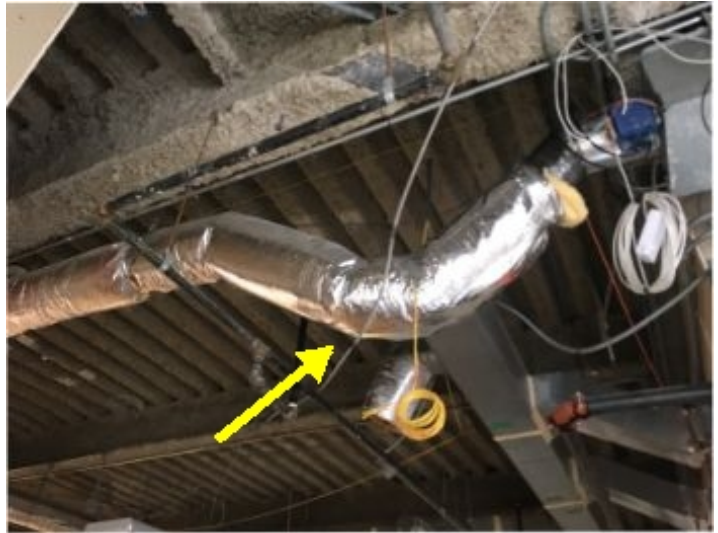
- HVAC duct work was crushed or missing insulation throughout the entire building. Recommend review by licensed Mechanical contractor.

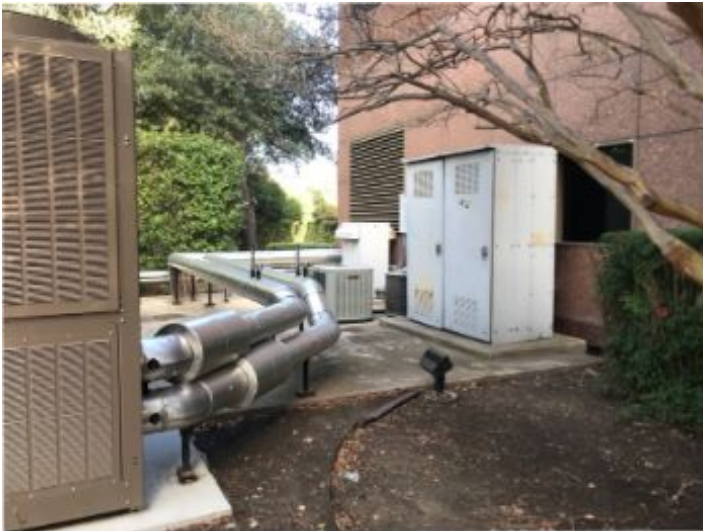
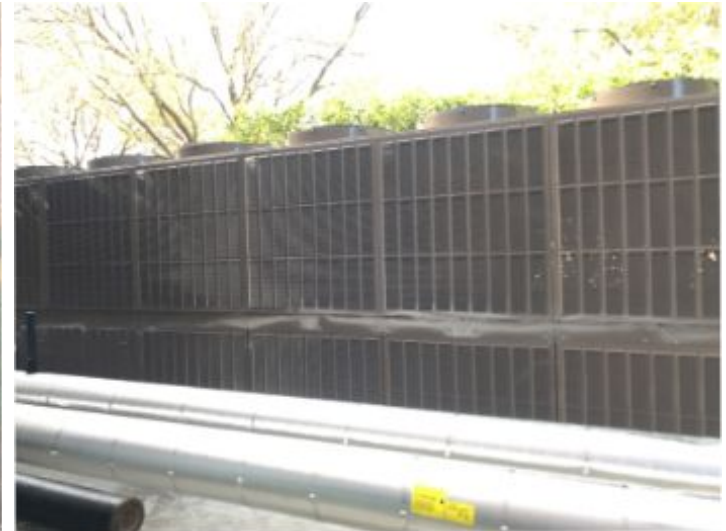
• **The Chiller had two coils/systems and 4 air handlers (one for each floor). The air handlers were end of life. The chiller had one side low on coolant and the other had no coolant left at all. The system is a 2019 York. Recommend full review of system to determine cause of refrigerant leaks and to recharge system for proper testing/evaluation.**

• There are no current service records that we could locate, (usually they are attached to the equipment or nearby in the same room). We recommend that these units be serviced at least twice annually to maintain and extend the life of the equipment. Since we are uncertain as to whether regular servicing of this equipment has been done and are only able to inspect the unit visually from the exterior, we recommend that you have an HVAC technician service and examine this unit as needed. It may also be appropriate to enter into a maintenance contract with a commercial HVAC company.

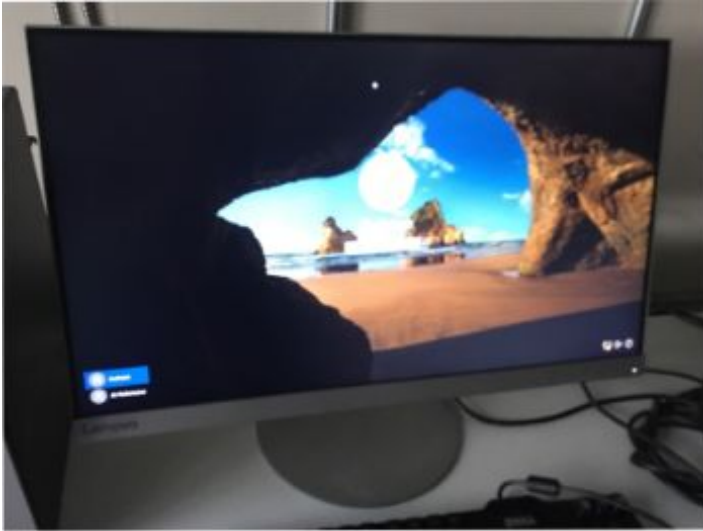
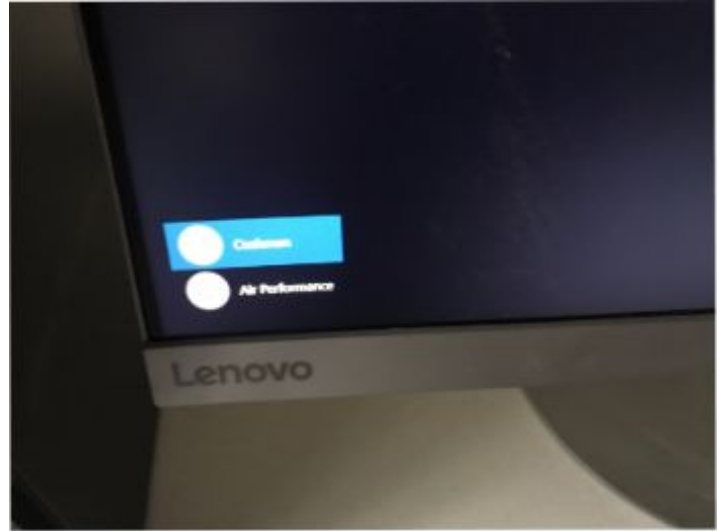
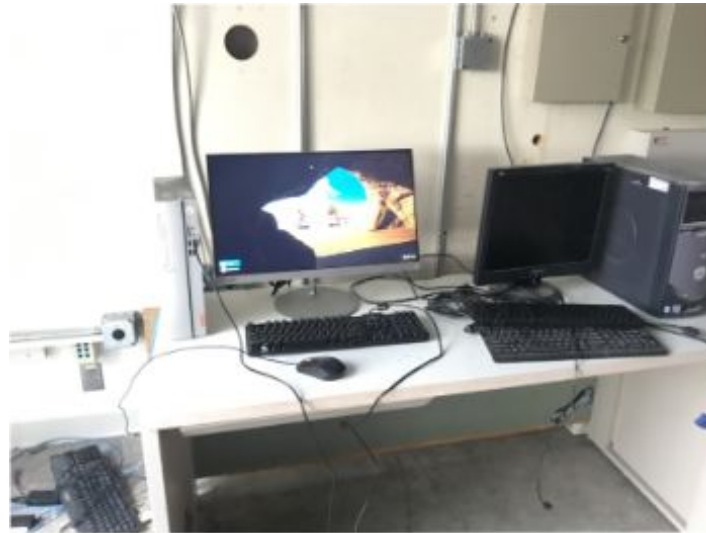
- Condition is unknown, as I was unable to test this system as it requires a password.
