COMMERCIAL INSPECTION REPORT

12/5/2020

Richardson, TX

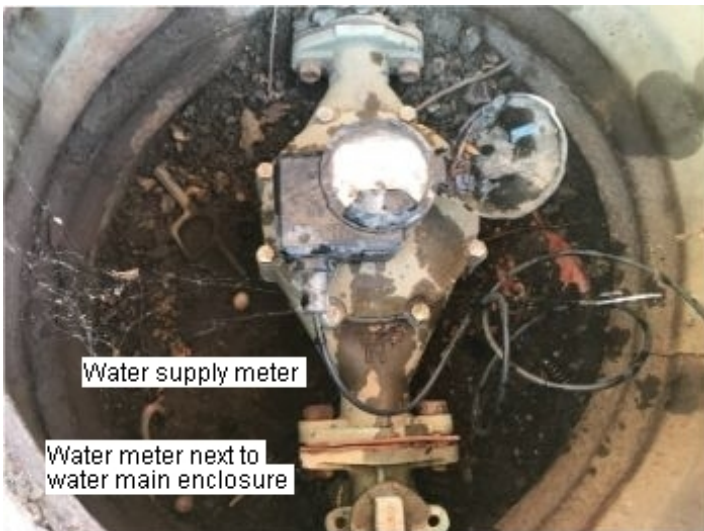
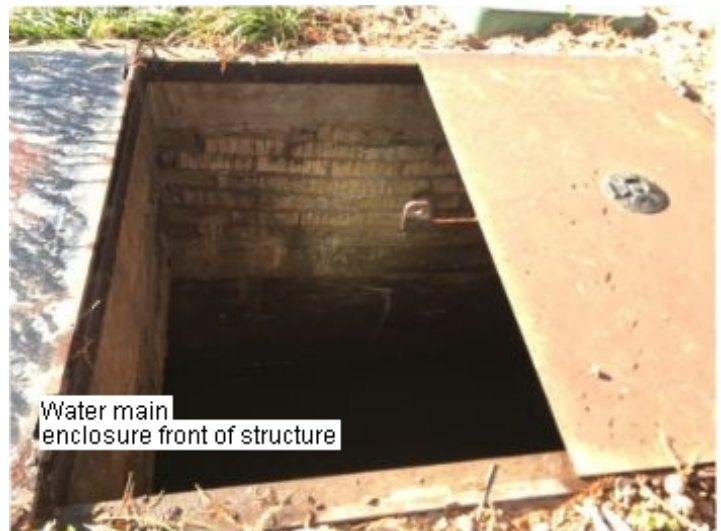
• **Damage/Defects noted at: water main which is submerged under water. Rusted pipes noted at exterior in upper roof section. The water supply pump was running and discharging a large amount of water ; the pressure was measured at 160 (max) which is a concern. The water supply tank bladder is suspected to be defective. The main water back flow valve supports are rusted and end of life. See photos.**

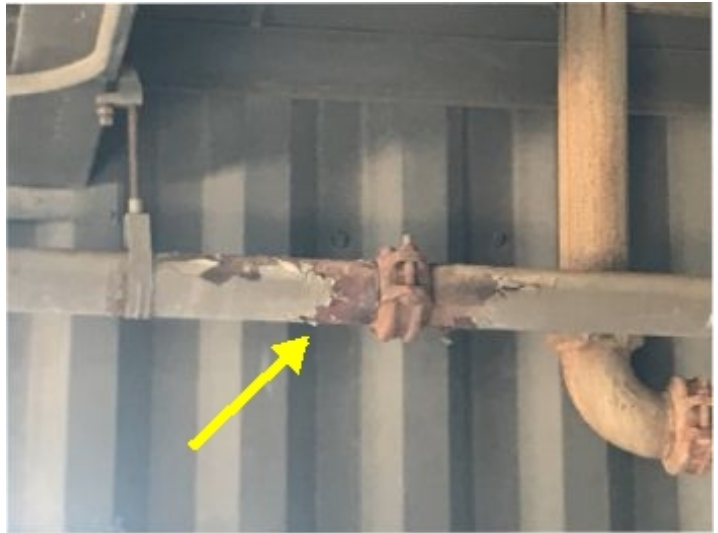
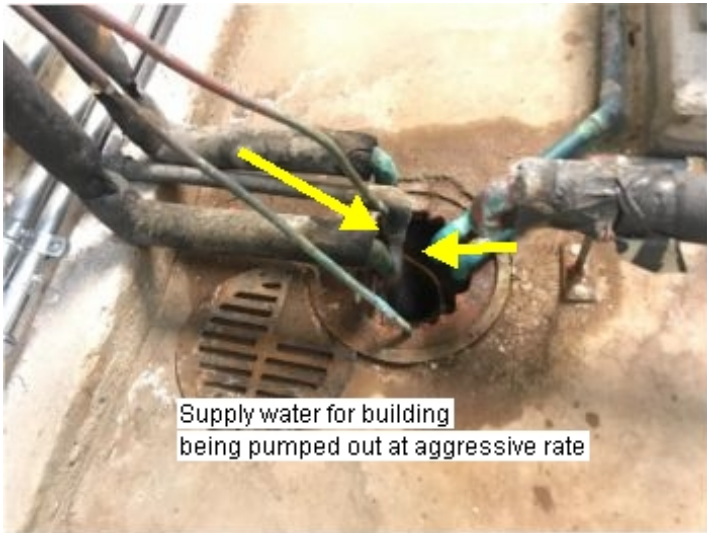
Supply water for building being pumped out at aggressive rate

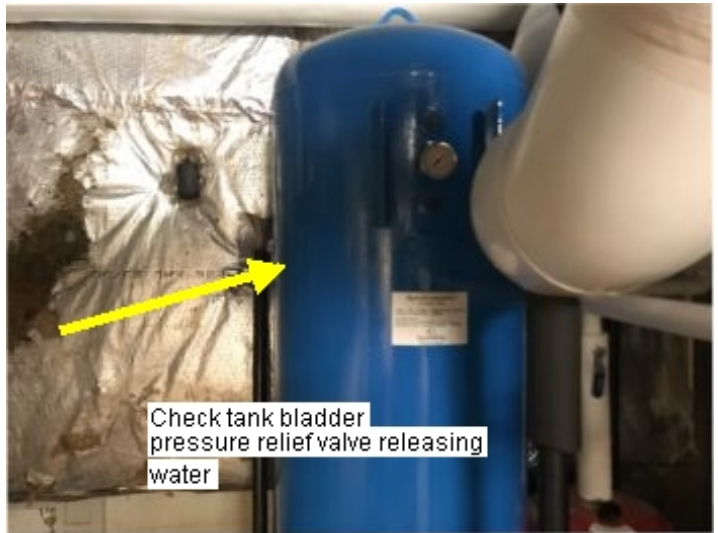
Check tank bladder pressure relief valve releasing water

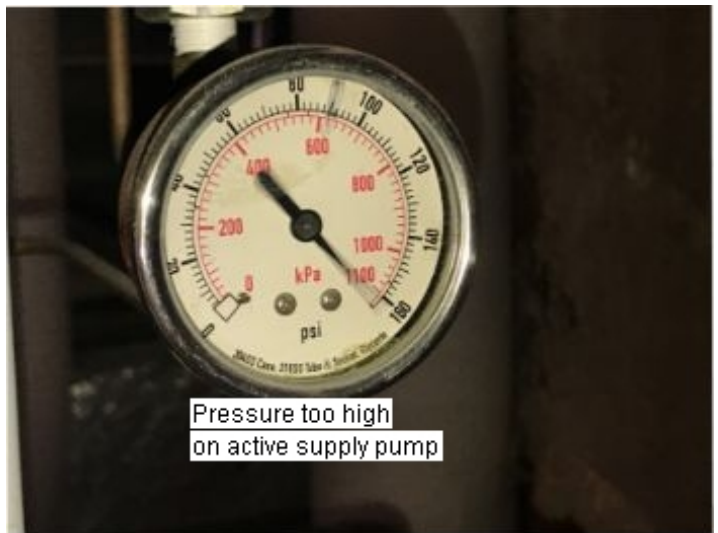
Supply pump running

Pressure too high on active supply pump

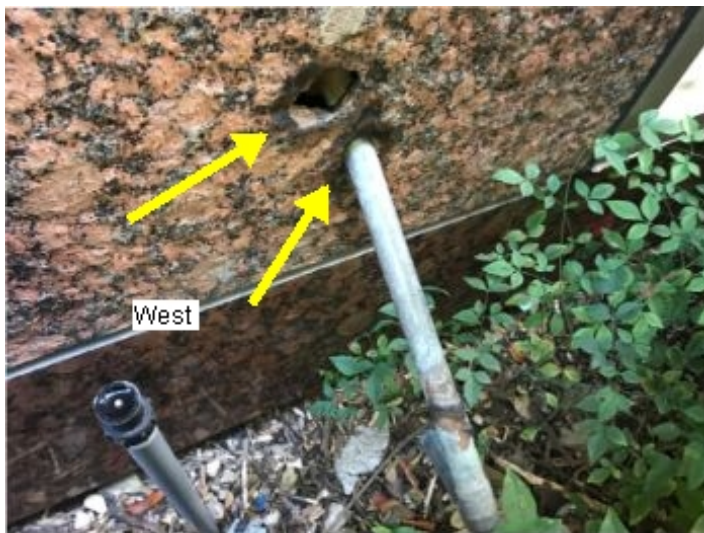
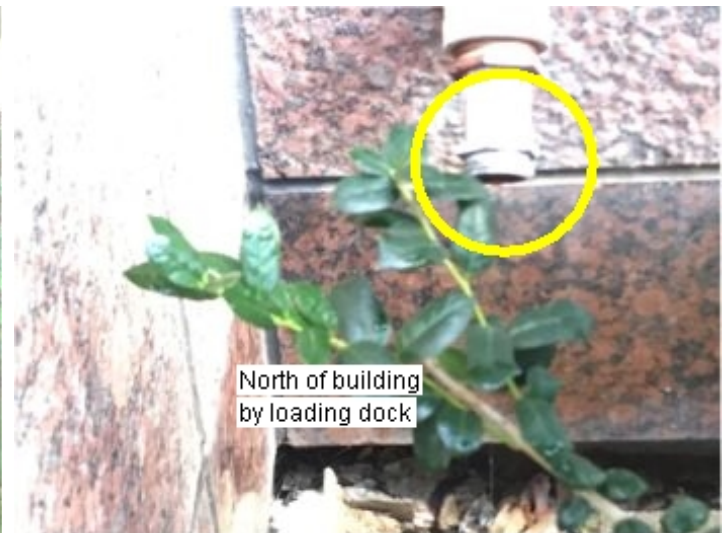
- There is a pipe or conduit on the West side with an open hole to the interior.
- There is a roof vent that is the incorrect height.
- There is a drain pipe next the left of the loading dock that is dripping/leaking. Source of water/drainage could not be determined.

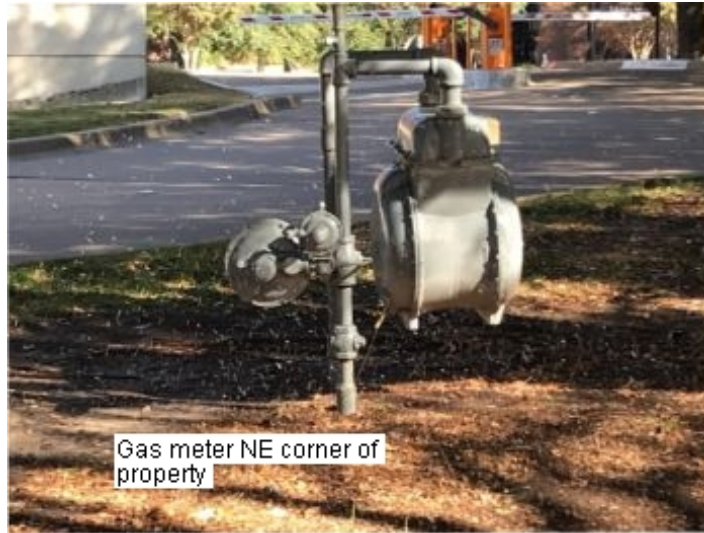
Gas meter NE corner of property

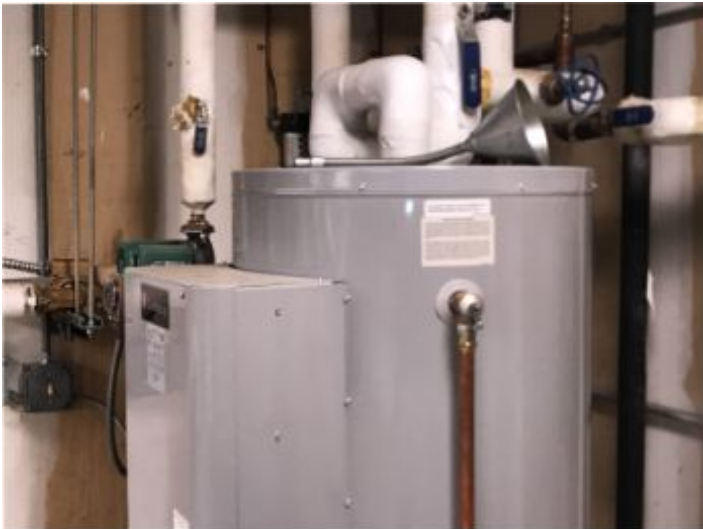
- The water heater is a Lochinvar made in 2010. It is electrically heated with 3 heating elements. it could not be tested at the time of the inspection.

Lochinvar 2010 electric water heater

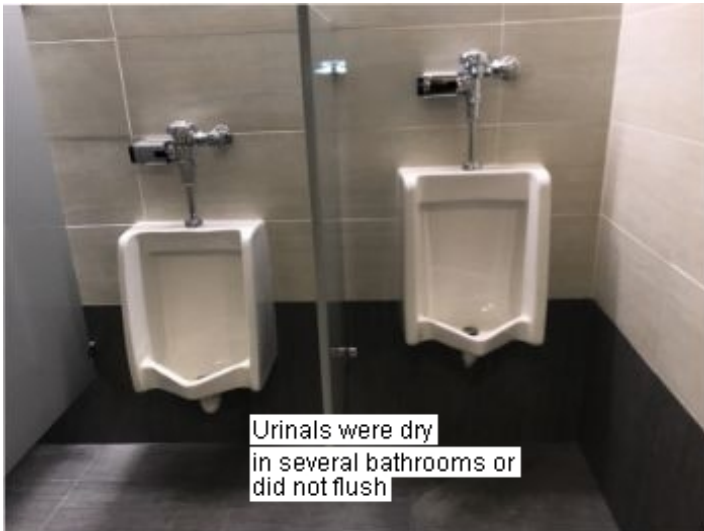
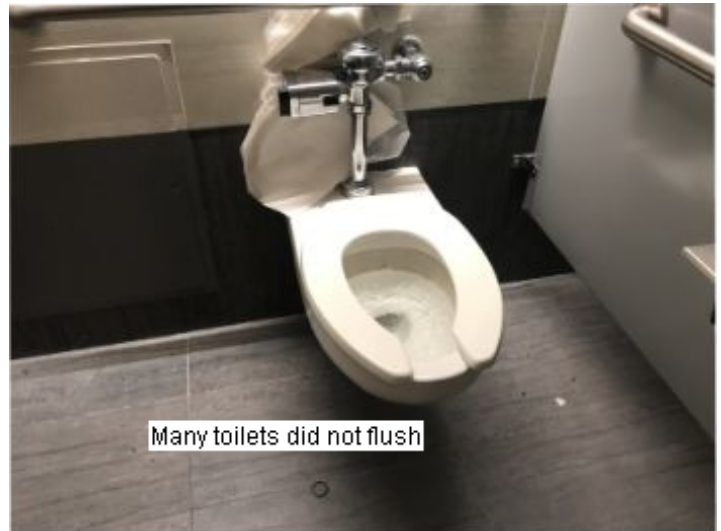
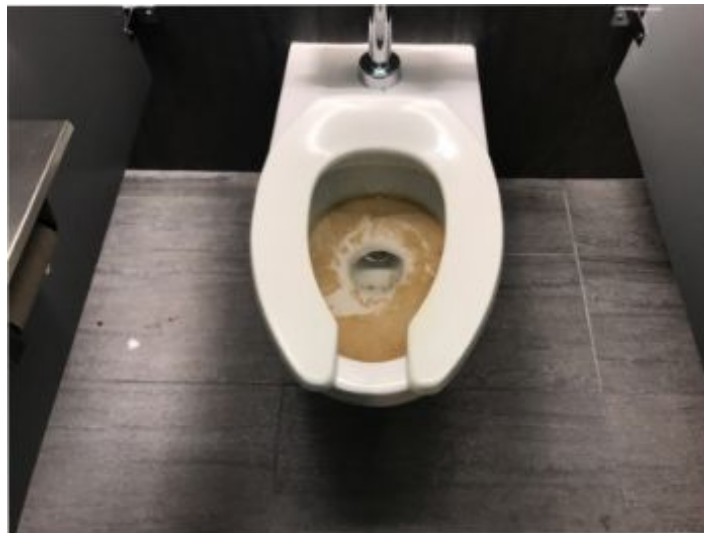
- Main toilets were abandoned and could not be used.
- Some urinals were "dry" meaning no water.

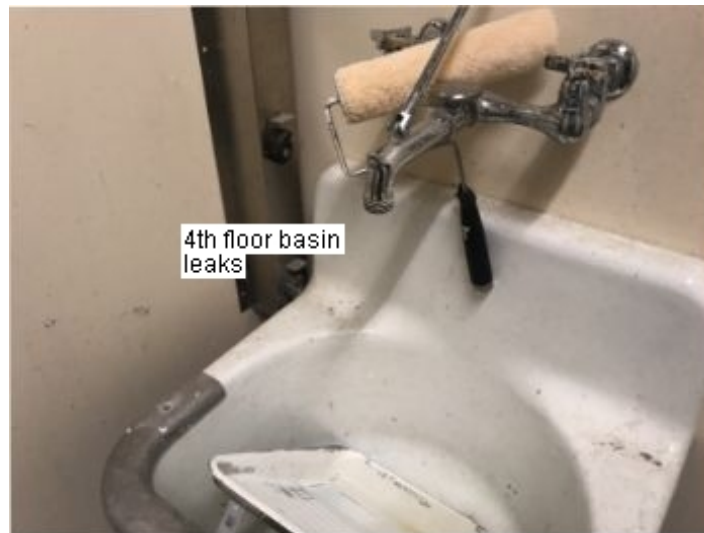
- Mop sinks were present on each floor. The third and fourth floor basins were end of life; heavily stained or leaking.

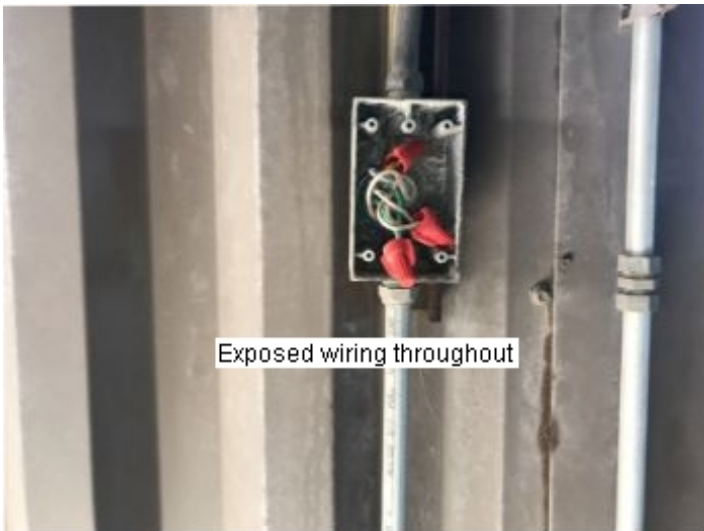
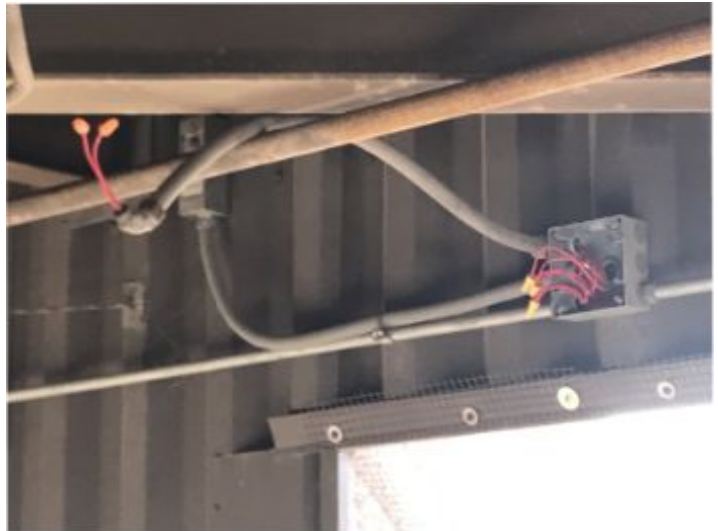
- There are several live wires and open junction boxes throughout. Be careful many hazards throughout.
- Some receptacles are no live throughout (mostly on the south side of building).
- See photos

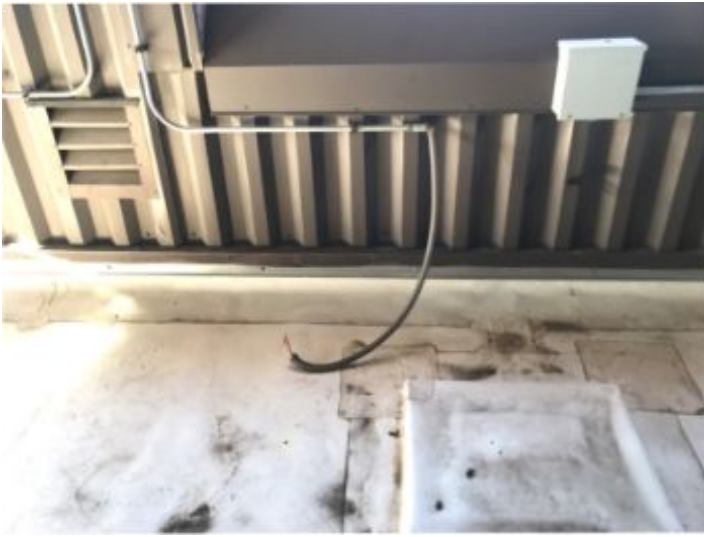
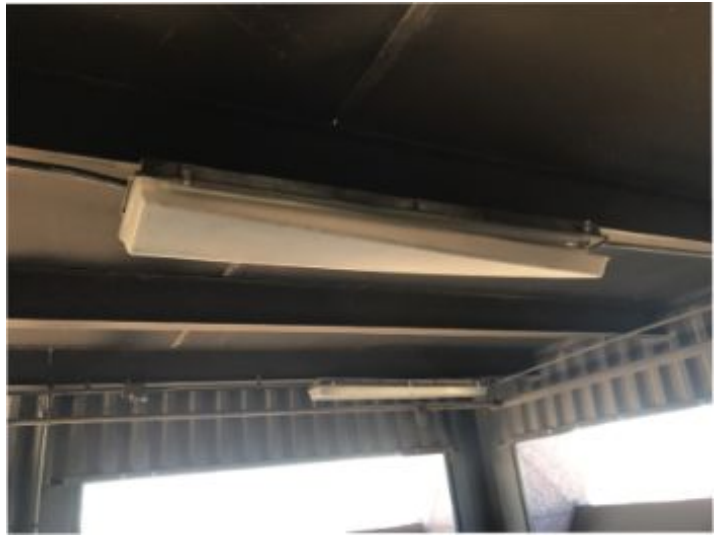
Electric cabinet by chiller is end of life

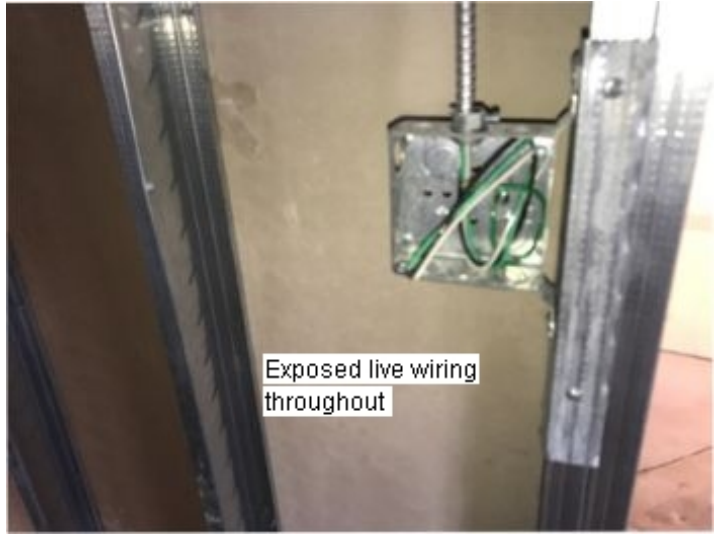
Exposed live wiring throughout

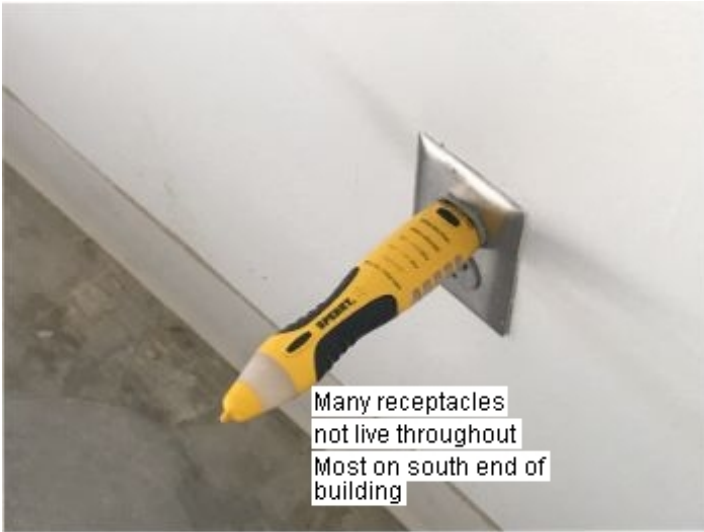
Many receptacles not live throughout
Most on south end of building

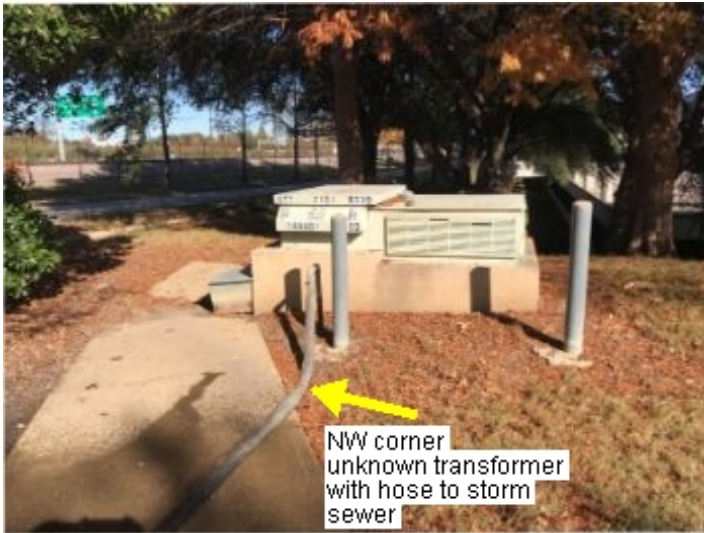
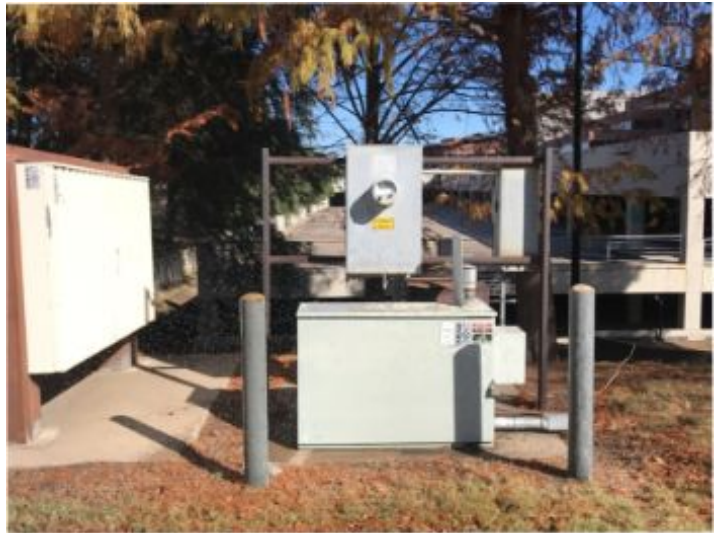
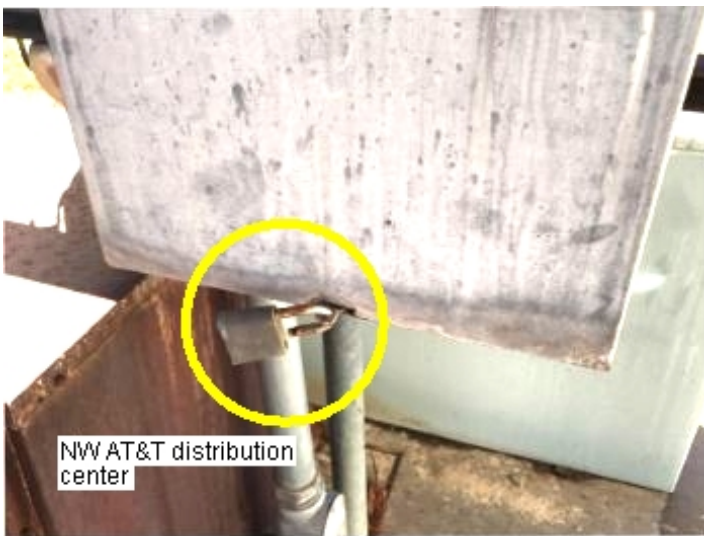
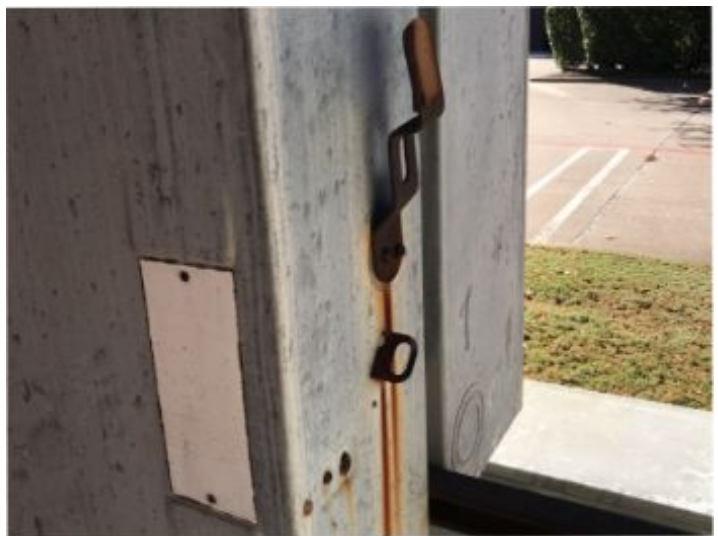
- There are several electric distribution centers located in the NW corner of the property. There is a hose connected to one that leads to the rain gutter. Inquiry into what this is for is recommended.
- See photos

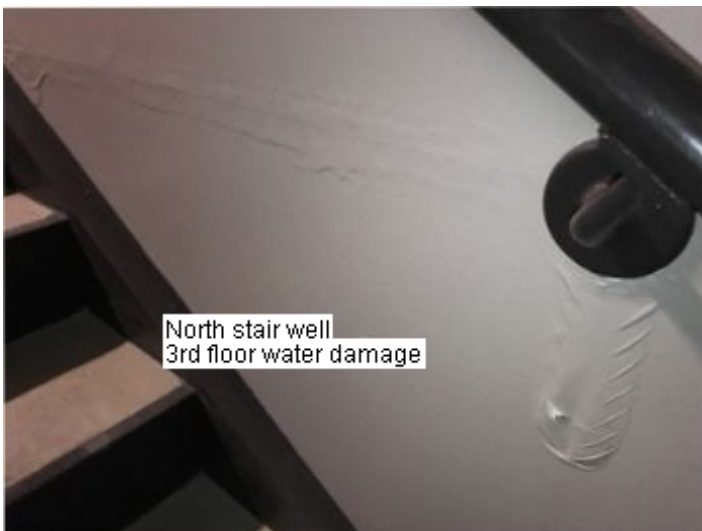
- Two possible water leaks were noted in the north stairwell 3rd floor and in the mechanical room on 3rd floor. As well as in HVAC closet on first floor.

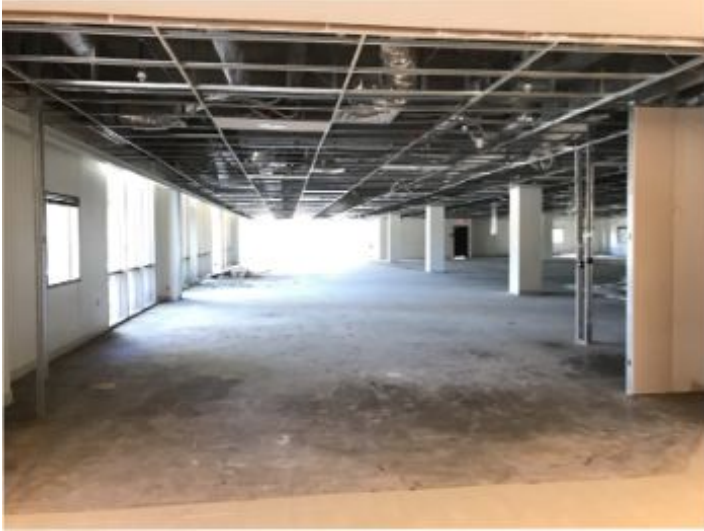
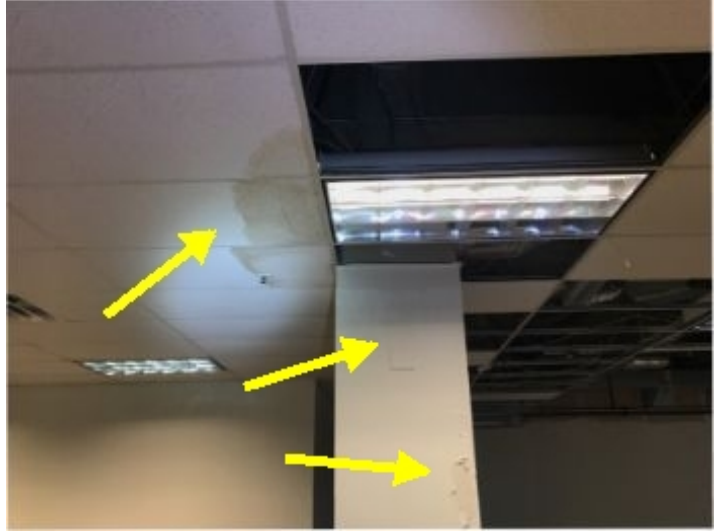
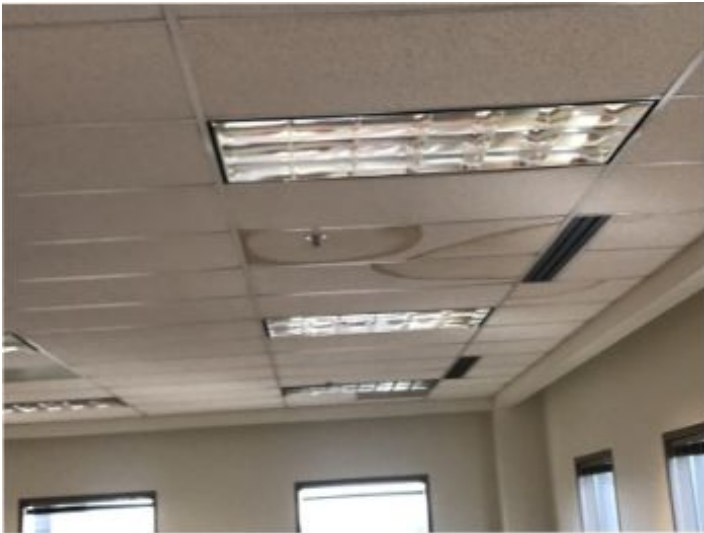
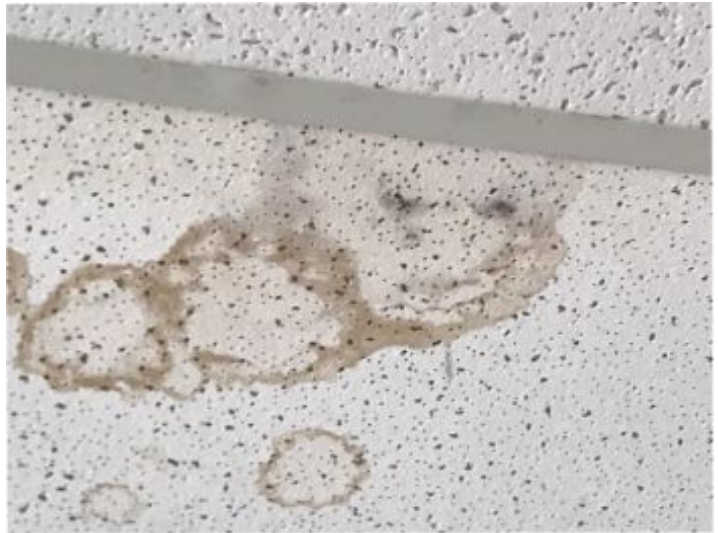
- The ceilings are comprised of Drop down T-Bar Panels.
- Moisture stains were noted throughout the 3rd and 4th floors. Suspect the fire system maybe be failing or rusting from the inside out.

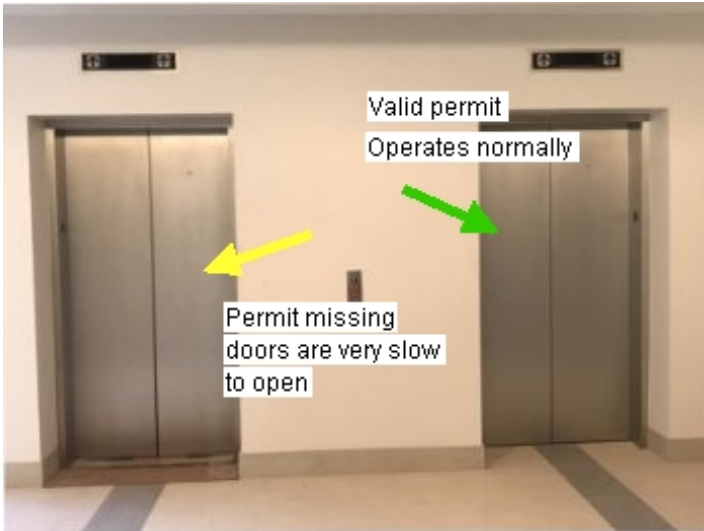
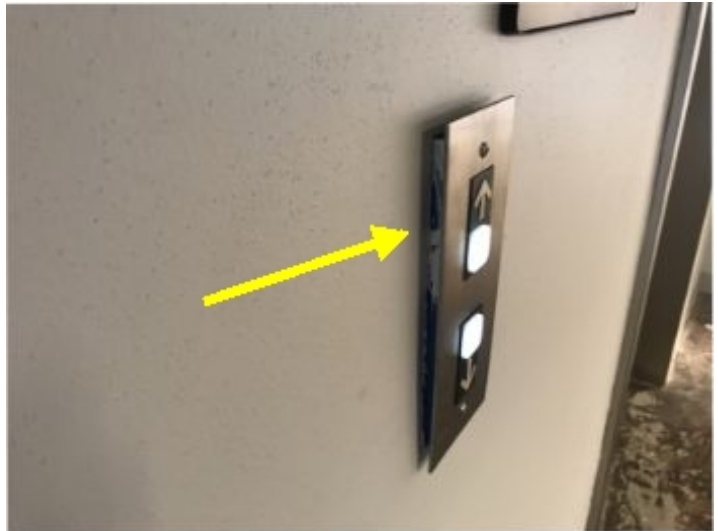
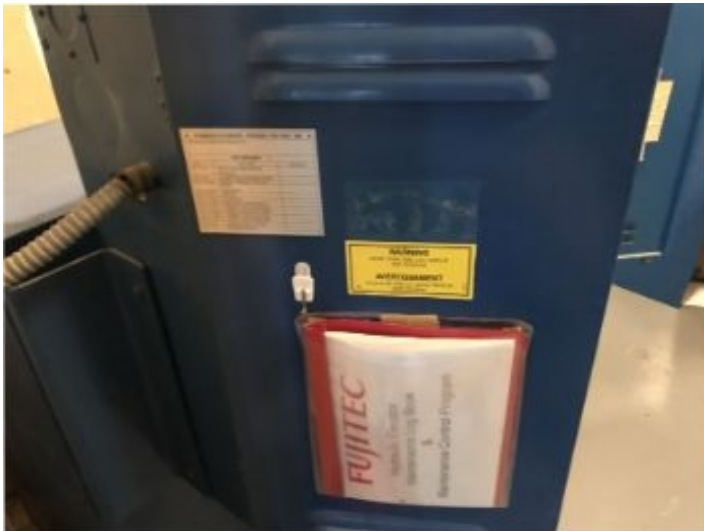
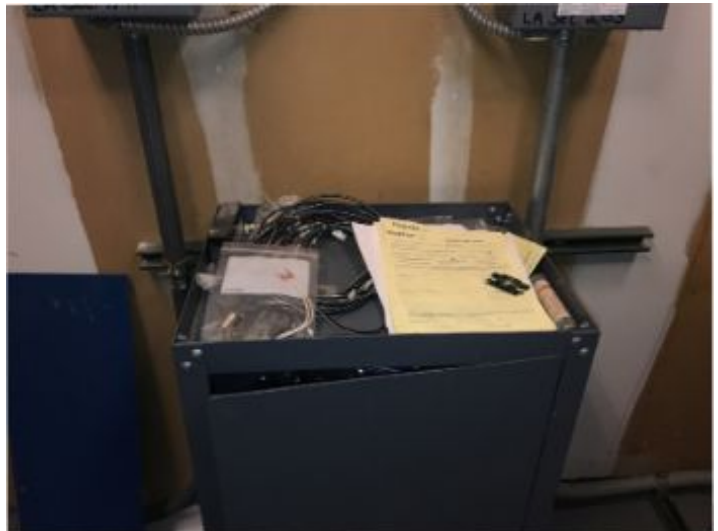
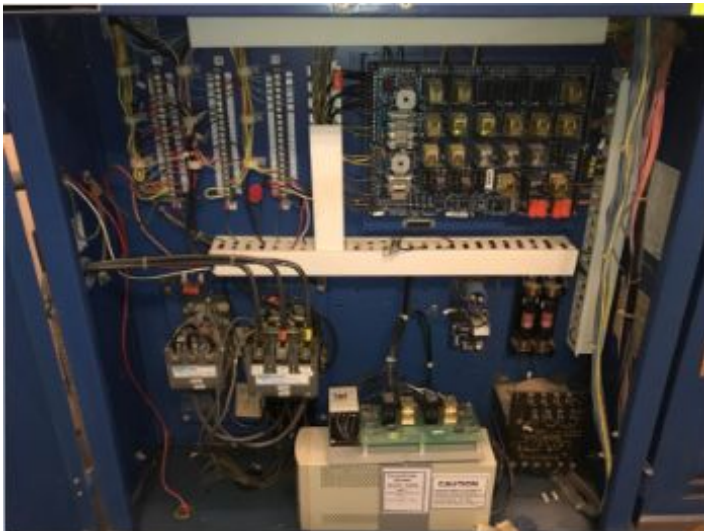
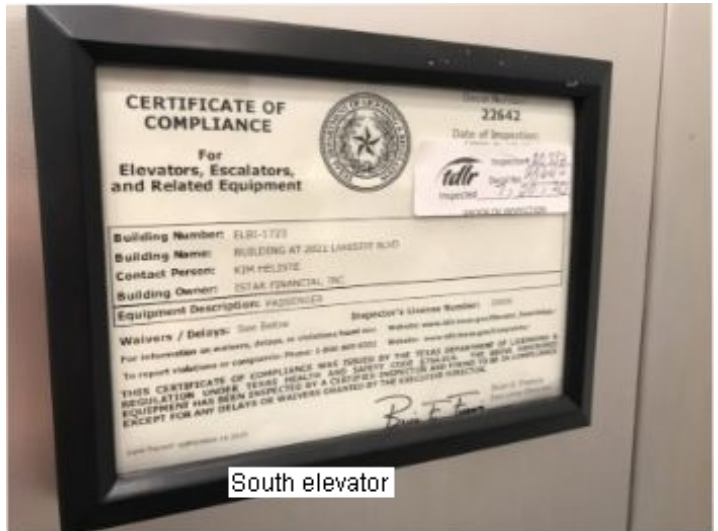
- The elevators in this structure were run on each floor and a up to date permit was documented if present. The north elevator is deficient and does not open correctly when it reaches a floor; its permit was not present either. The south elevator functioned as commanded and had a valid permit. The lift equipment and controls were open and appeared to need service (4th floor). Recommend review by licensed elevator contractor.
- The rails in the stairwells were working as directed.
- The south stairwell was missing proper lighting in various areas.
- The elevator command controls were loose in the wall on most floors.

South elevator

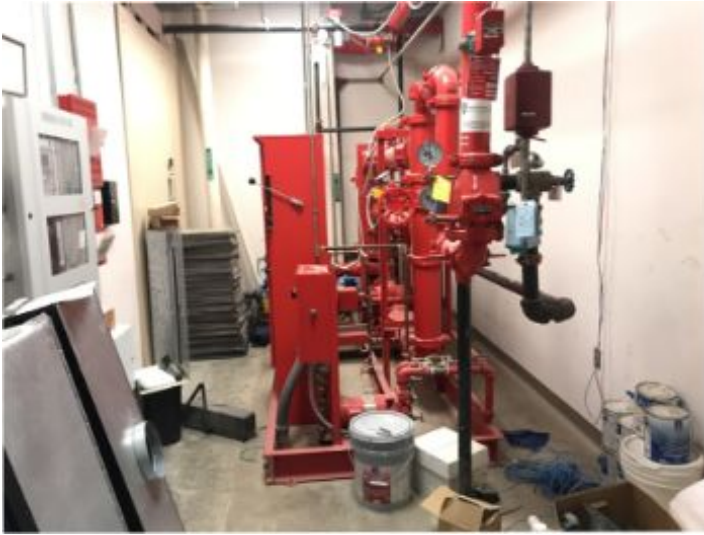
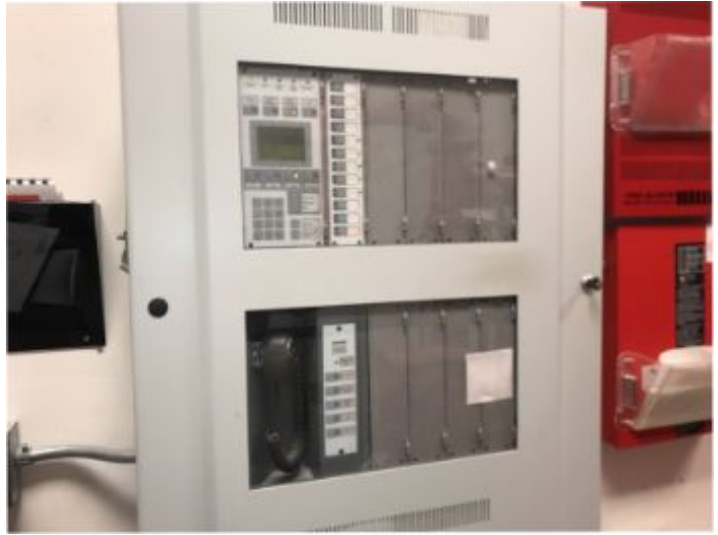
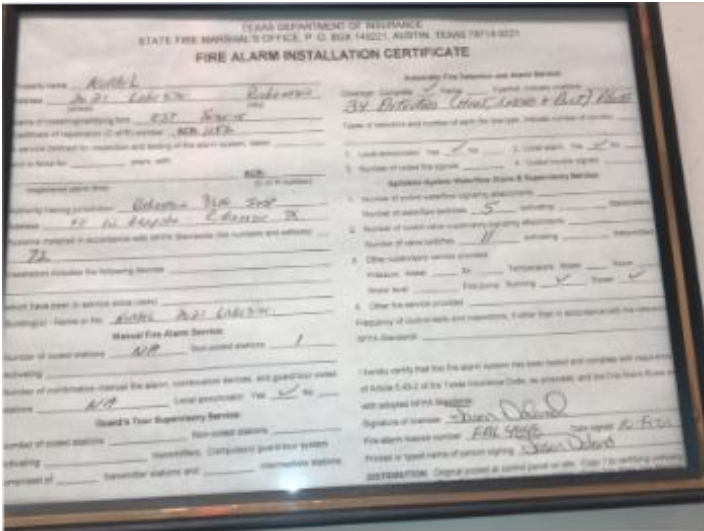
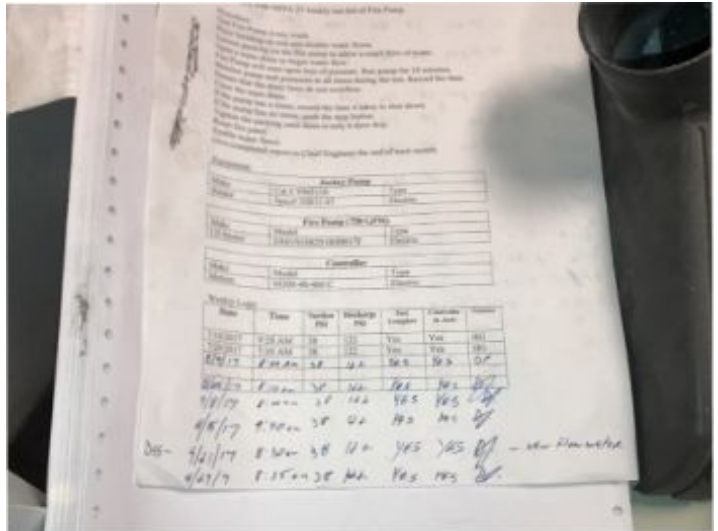
- A fire sprinkler system is installed for this structure, but inspection of these components is beyond the scope of this assessment.
- Various leaks were noted at the pump and the sprinkler pipes. Recommend review by specialized qualified contractor.
